PORT OF HOOD RIVER COMMISSION

AGENDA

Project: Hood River - White Salmon Interstate Bridge (ODOT Bridge Number 06645)

Subject: **2024 Portal Damage Assessment**

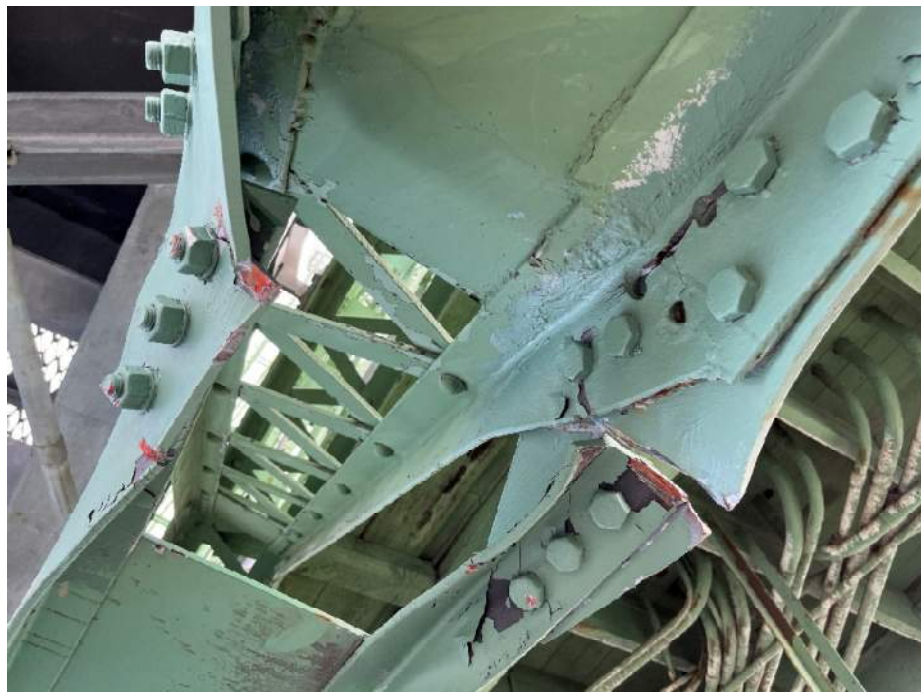
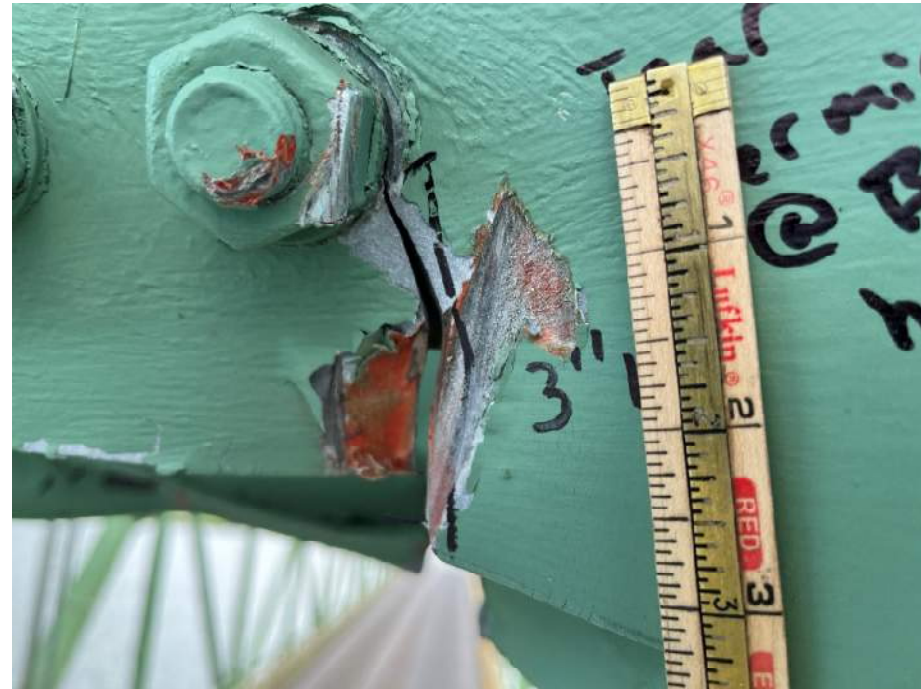
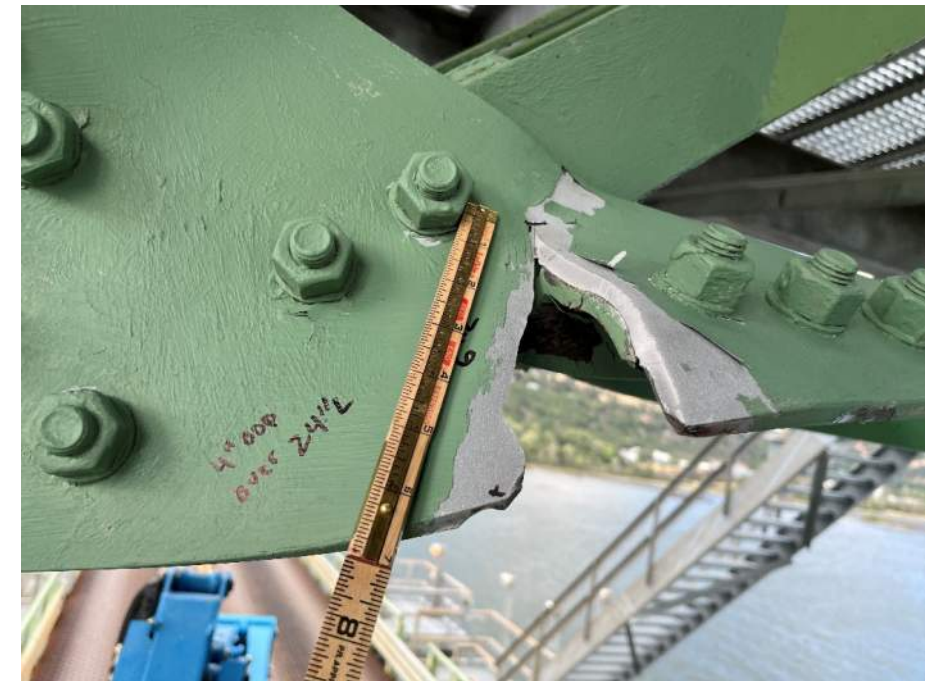
North Support Tower (Pier 12): Back Face Portal Details
Source: Dwg. 100741

Select Pictures of Observed Damage

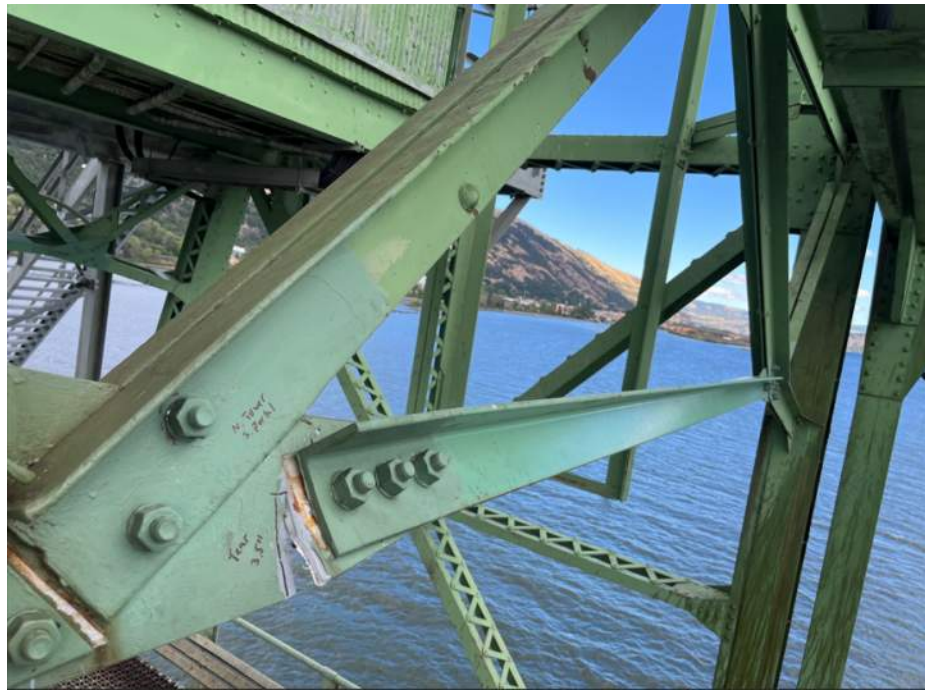
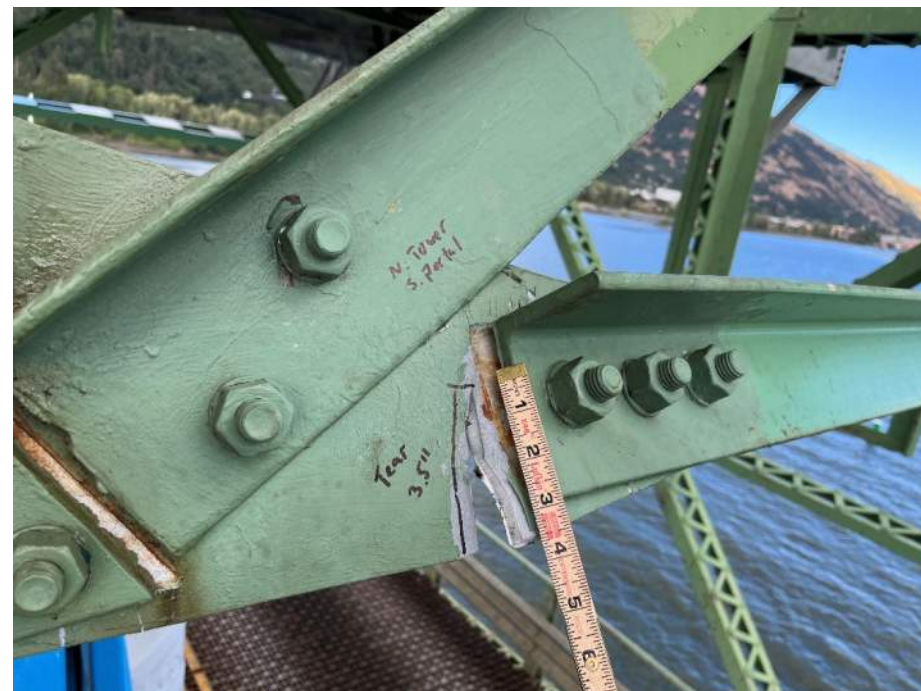
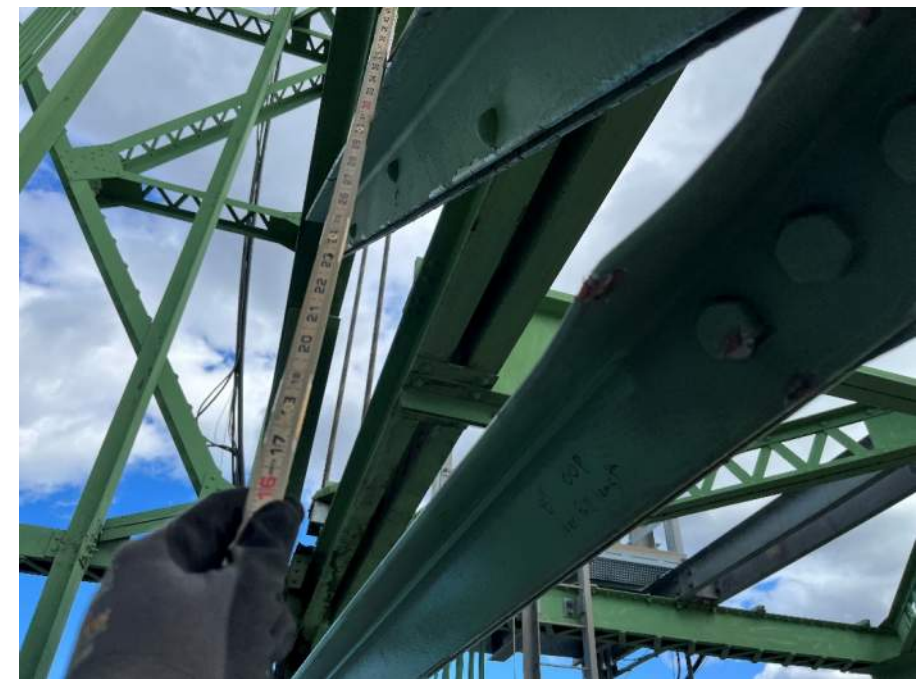
North Support Tower (Pier 12): Front Face Portal Details

Select Pictures of Observed Damage

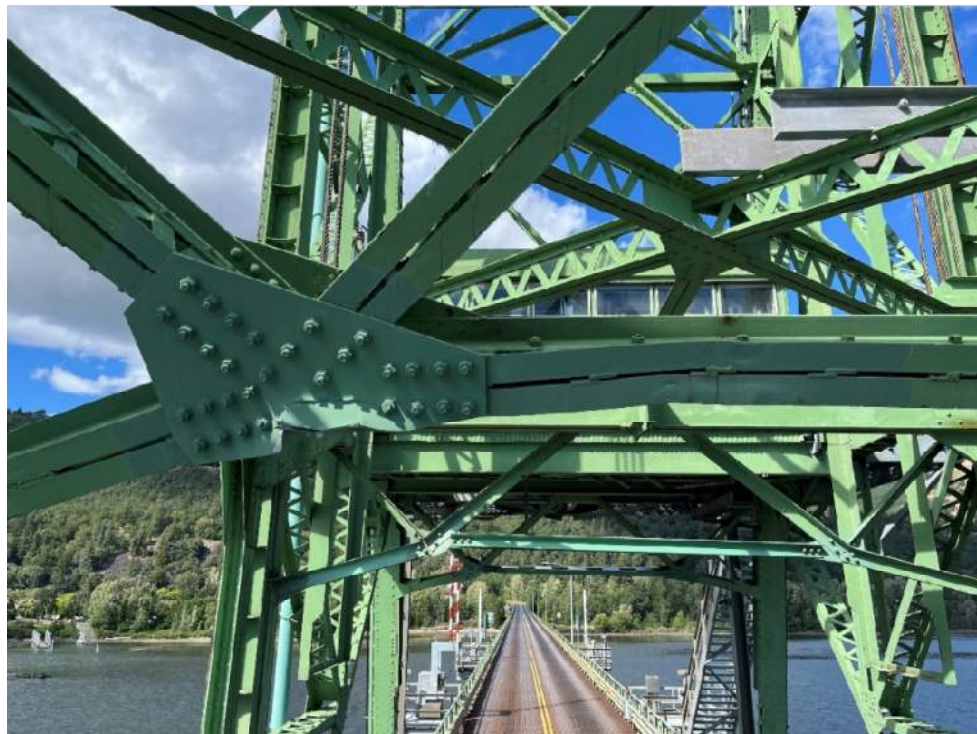
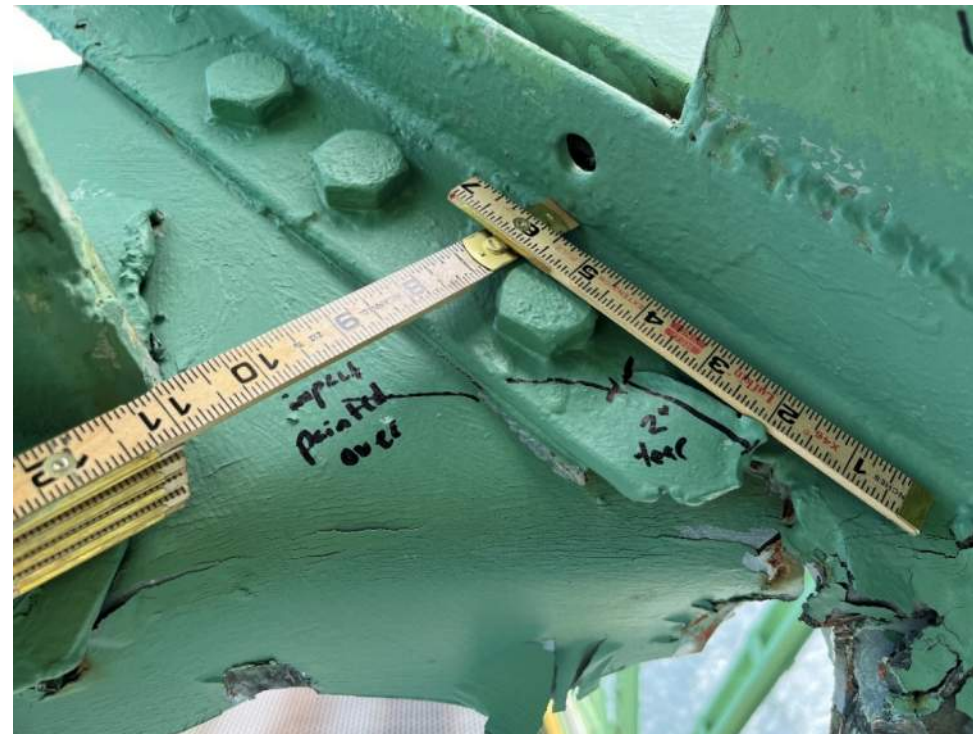
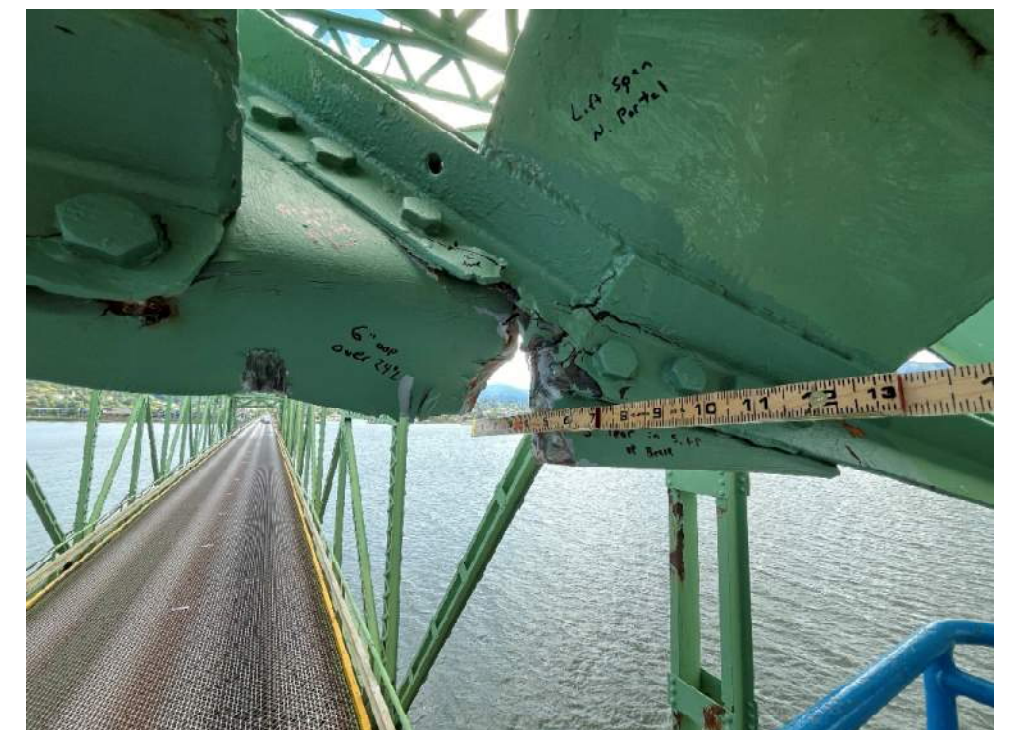
Truss Lift Span 11: North Portal Details
Source: Dwg. 102770

Select Pictures of Observed Damage

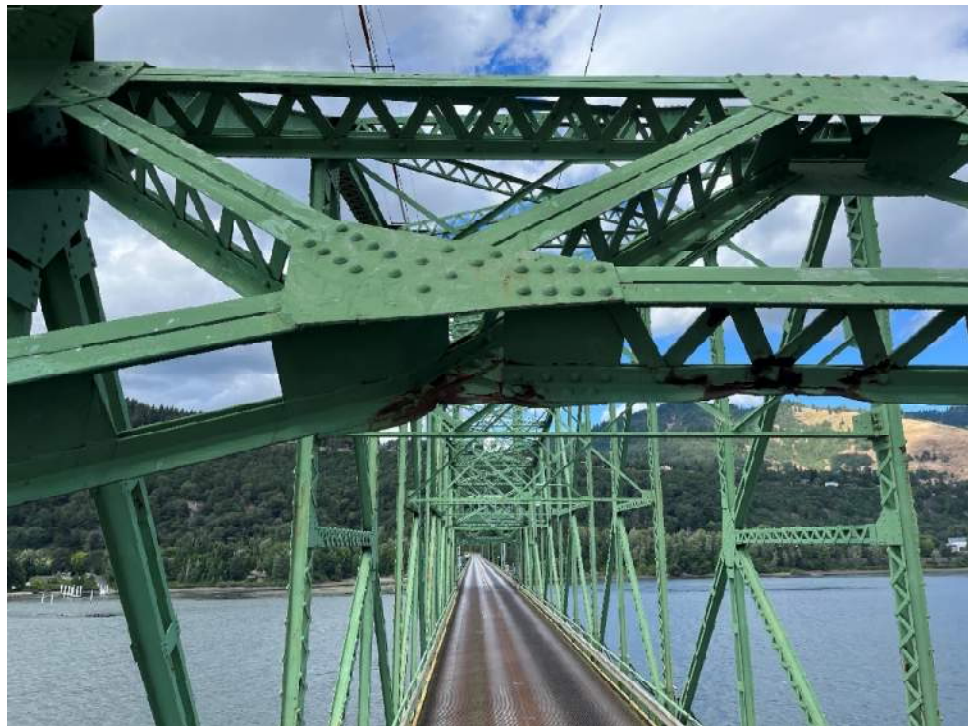
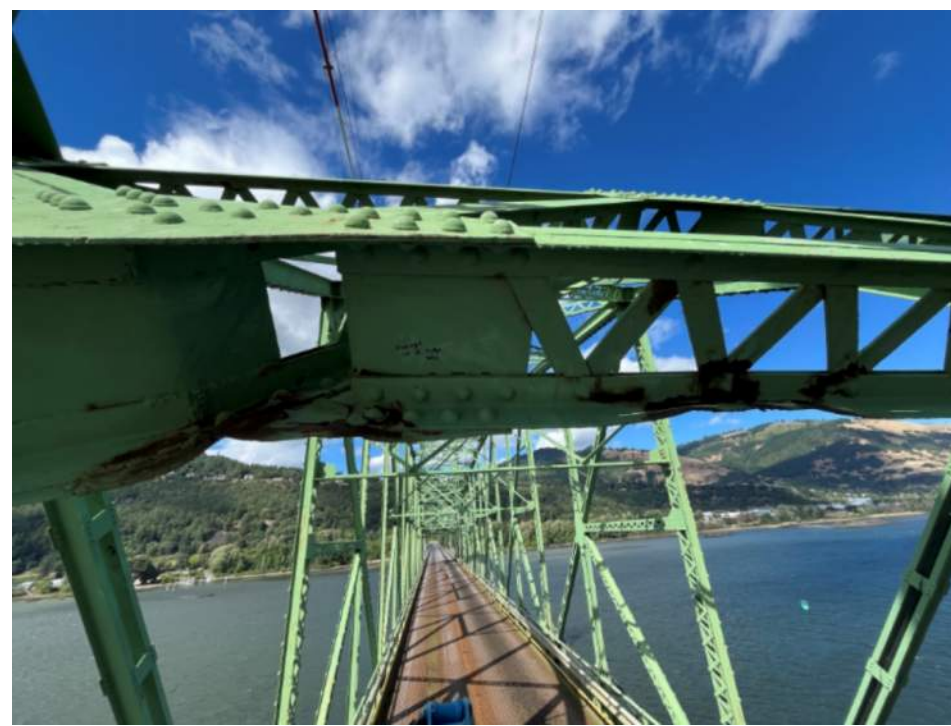
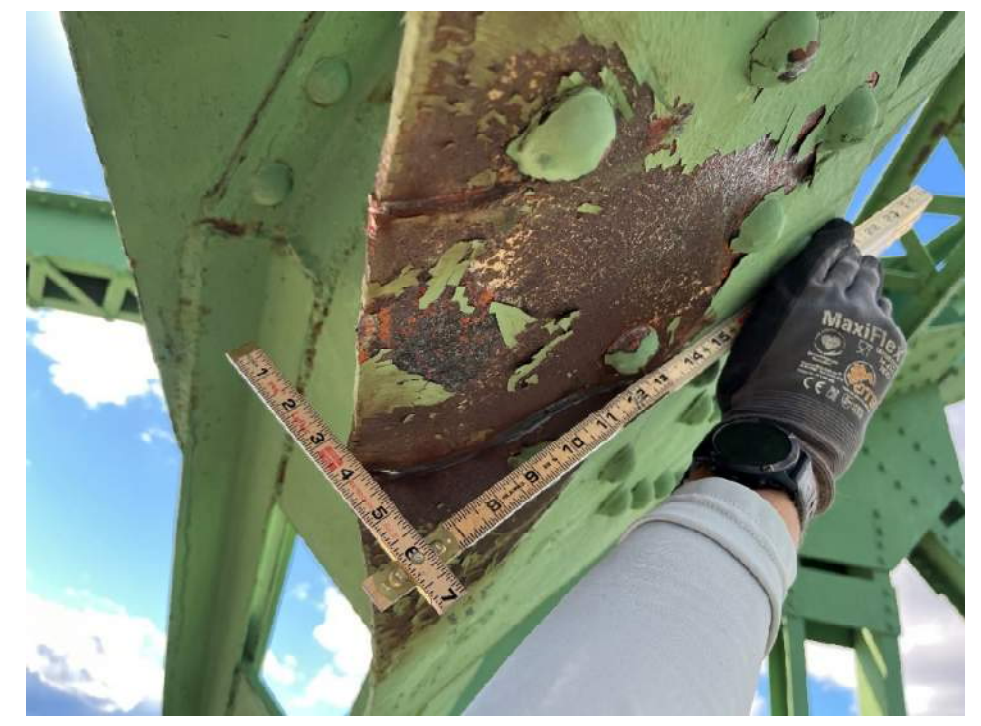
Truss Lift Span 11: South Portal Details
Source: Drawing File 362A

Select Pictures of Observed Damage

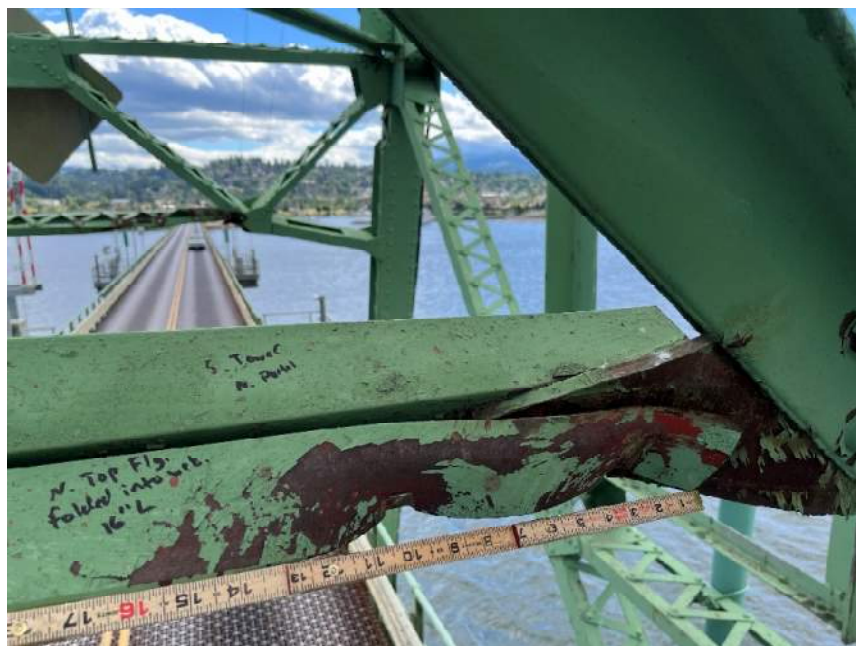
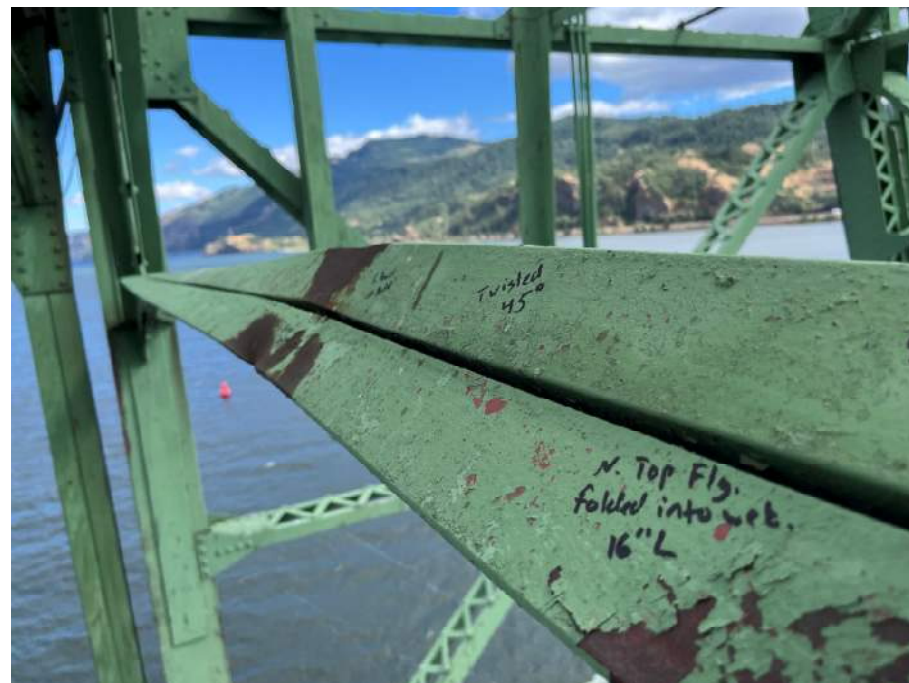
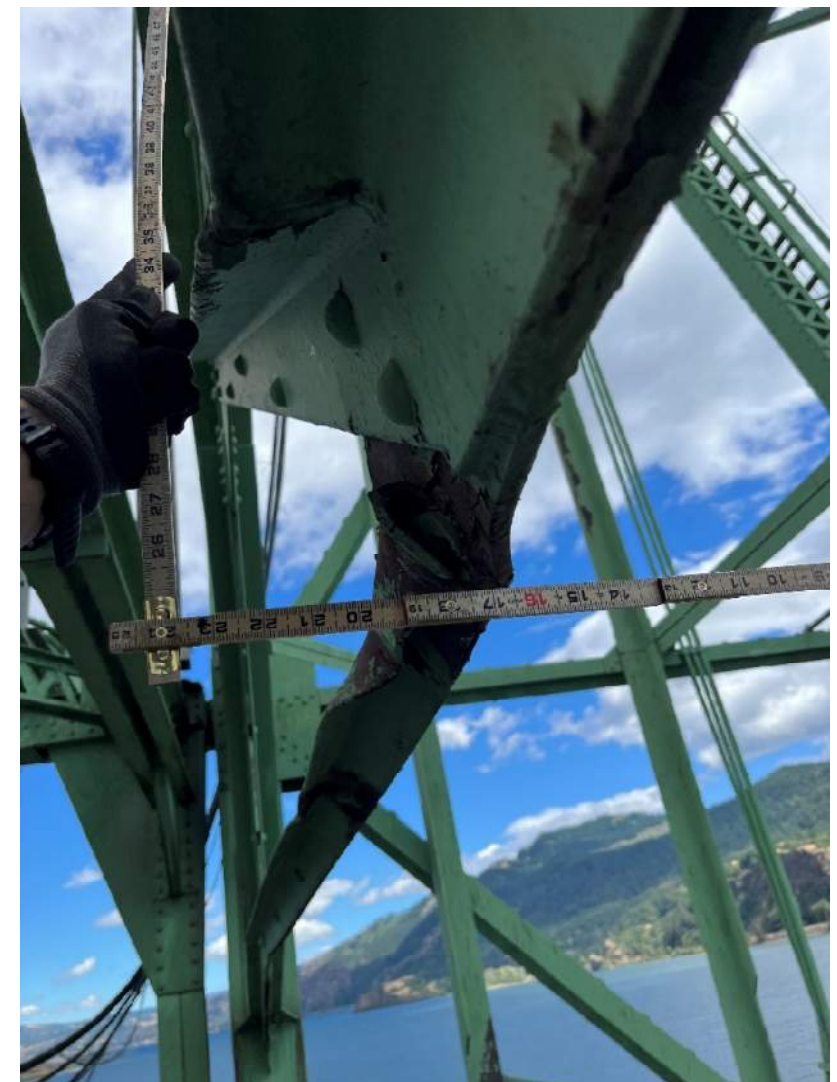
South Support Tower (Pier 11): Front Face Portal Details
 Source: Drawing File 362A

Pictures of Observed Damage

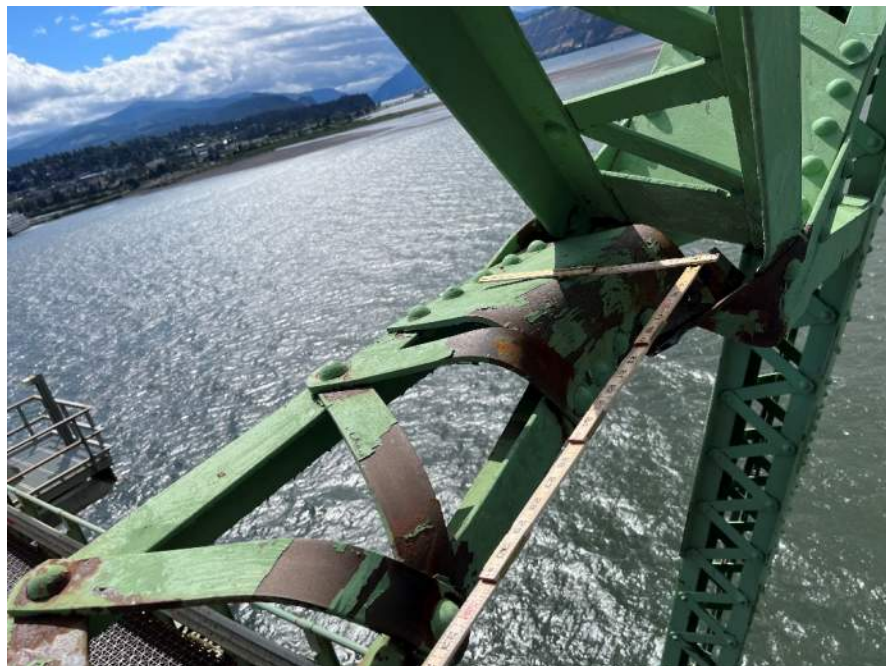
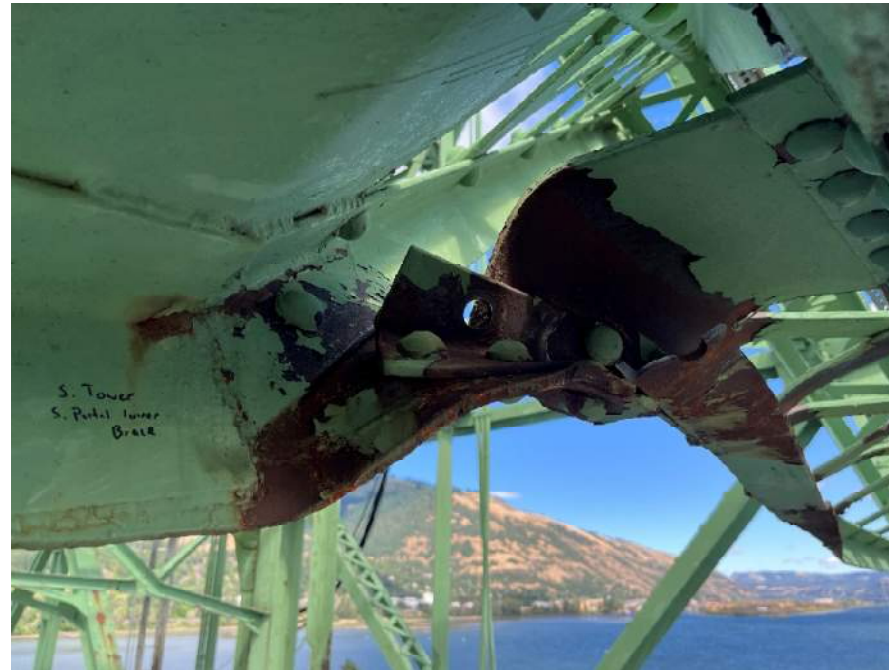
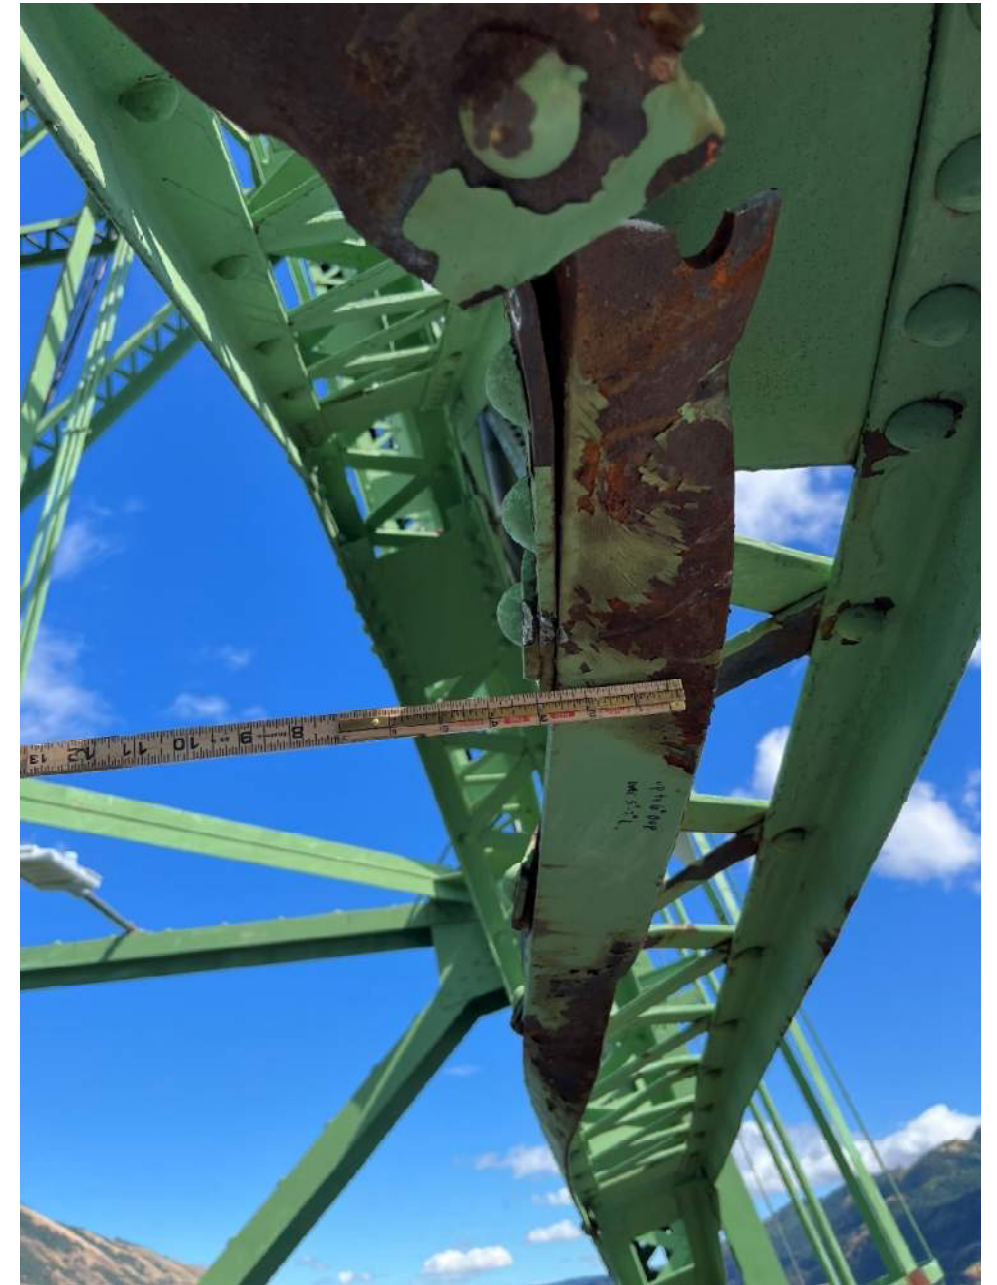
South Support Tower (Pier 11): Back Face Portal Details
 Source: Drawing File 362A

Select Pictures of Observed Damage

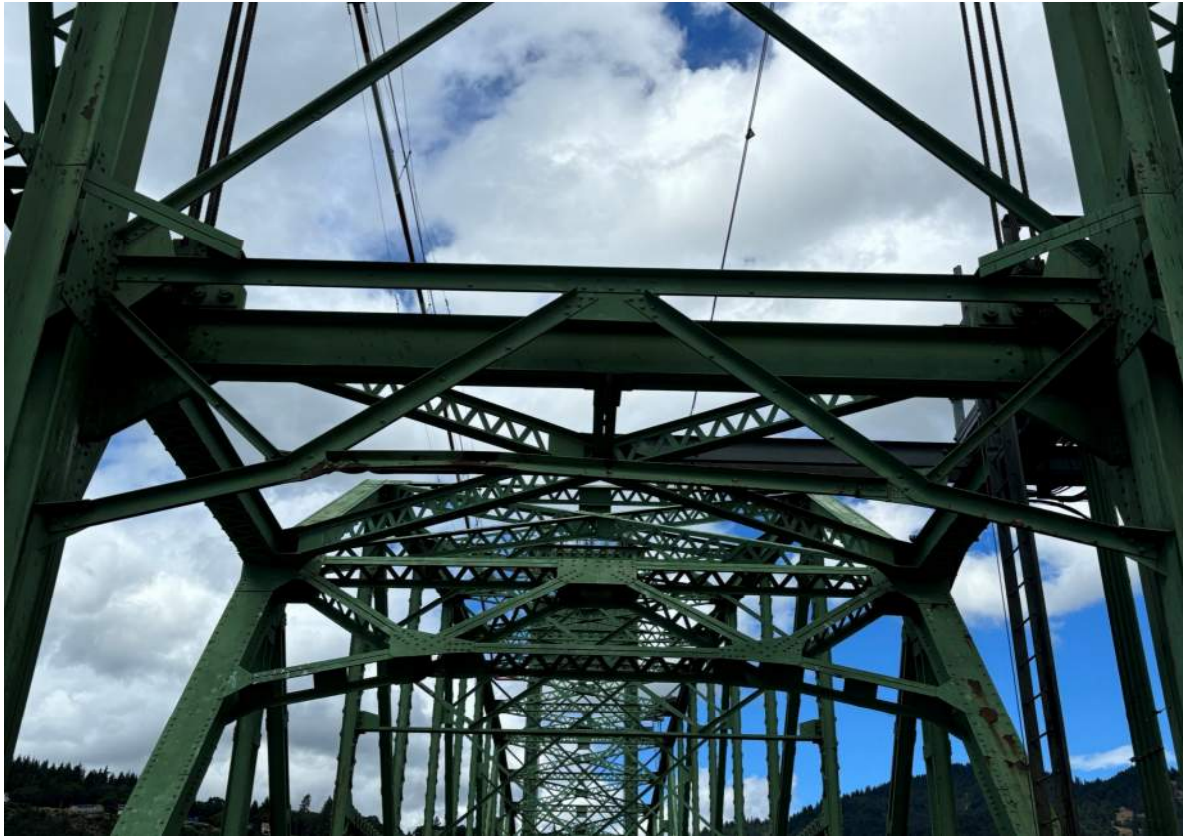
3) While force demands were shown to increase on portal members in the damaged configuration, they remained well below the capacity of the members.

Figure: Damaged portal frame in the lift span (lower third of the picture)

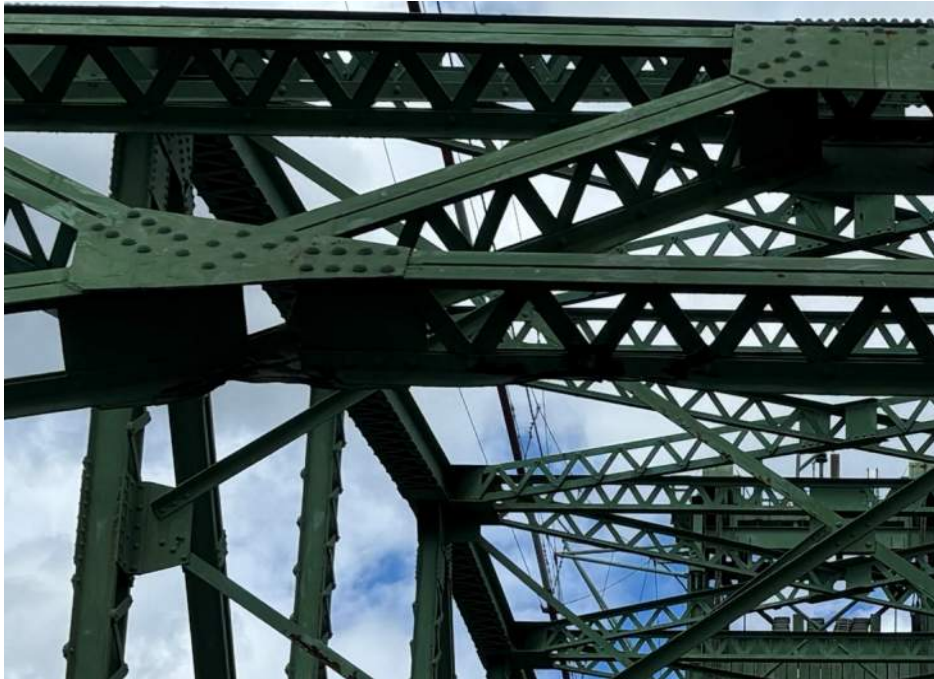
Figure: Damaged bottom chord

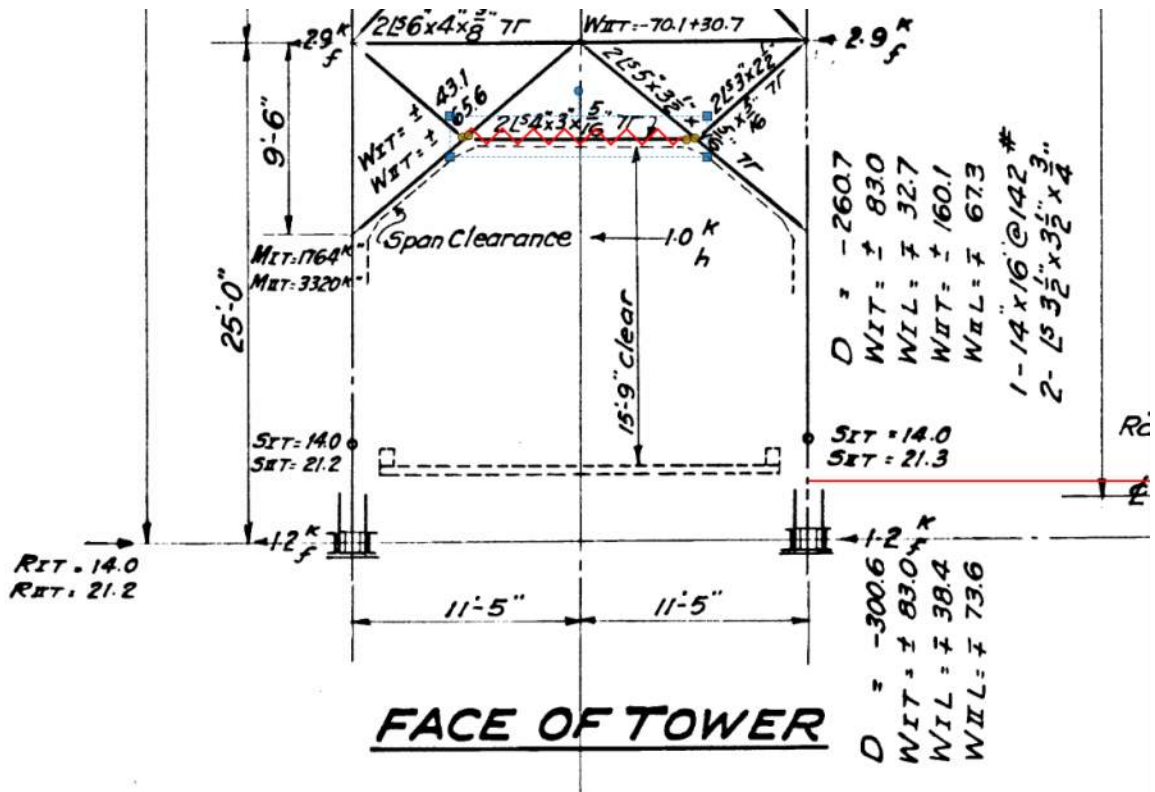
The substantially damaged member for this analysis is shown below. The analysis appears to show that this bottom chord member of the portal truss can be completely removed with no adverse impact on the structure's ability to resist wind loads.

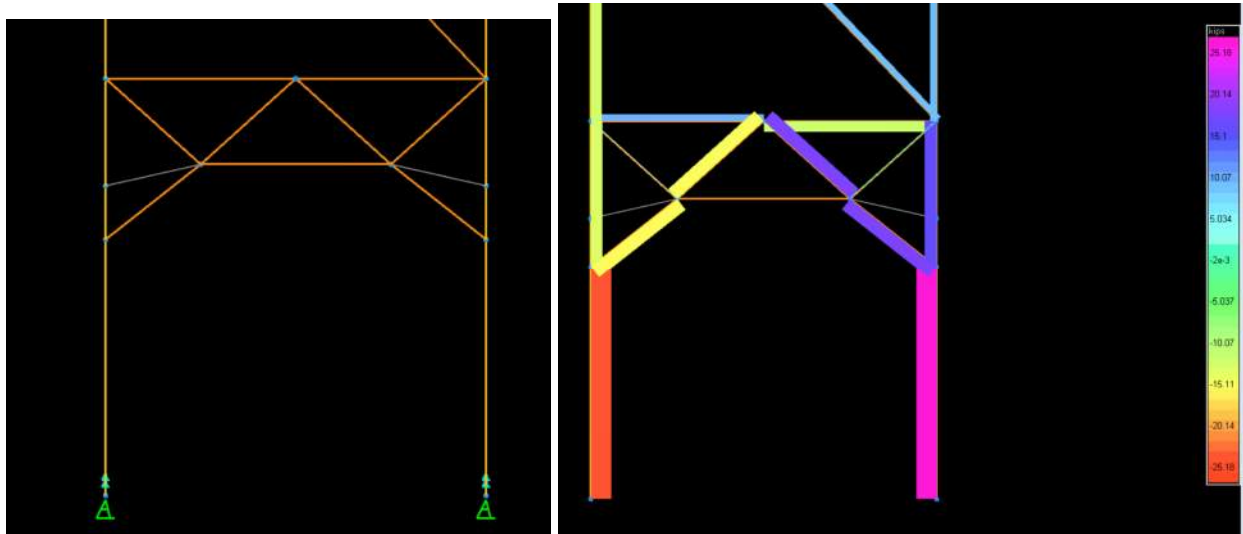
Original configuration (left) with member axial forces (right). Note the damaged bottom chord is a zero force member under this loading.

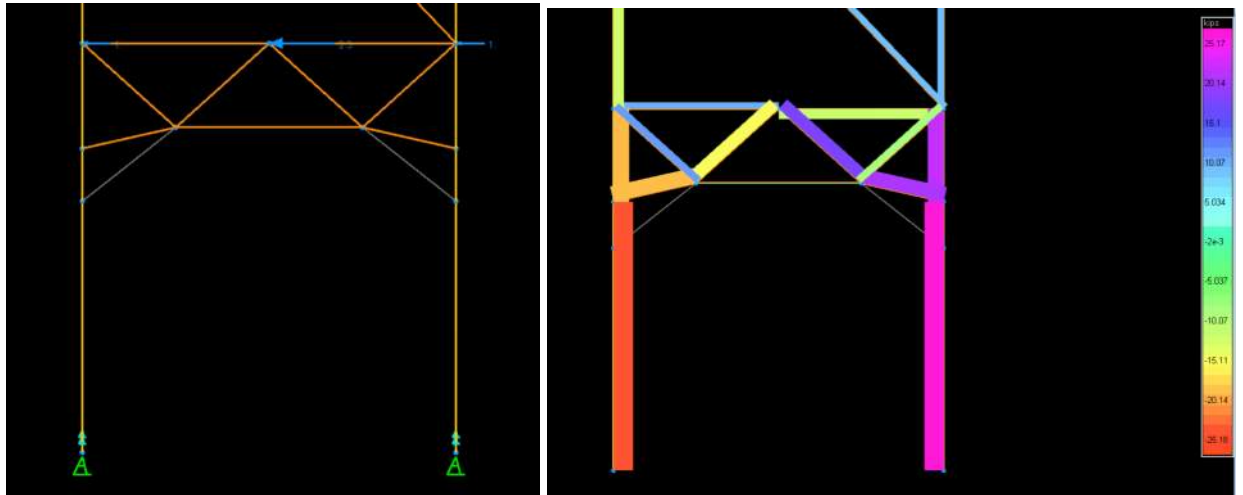
Modified 1967 configuration (left) with member axial forces (right). Note the damaged bottom chord is effectively still a zero force member carrying less than 100lbs of force.

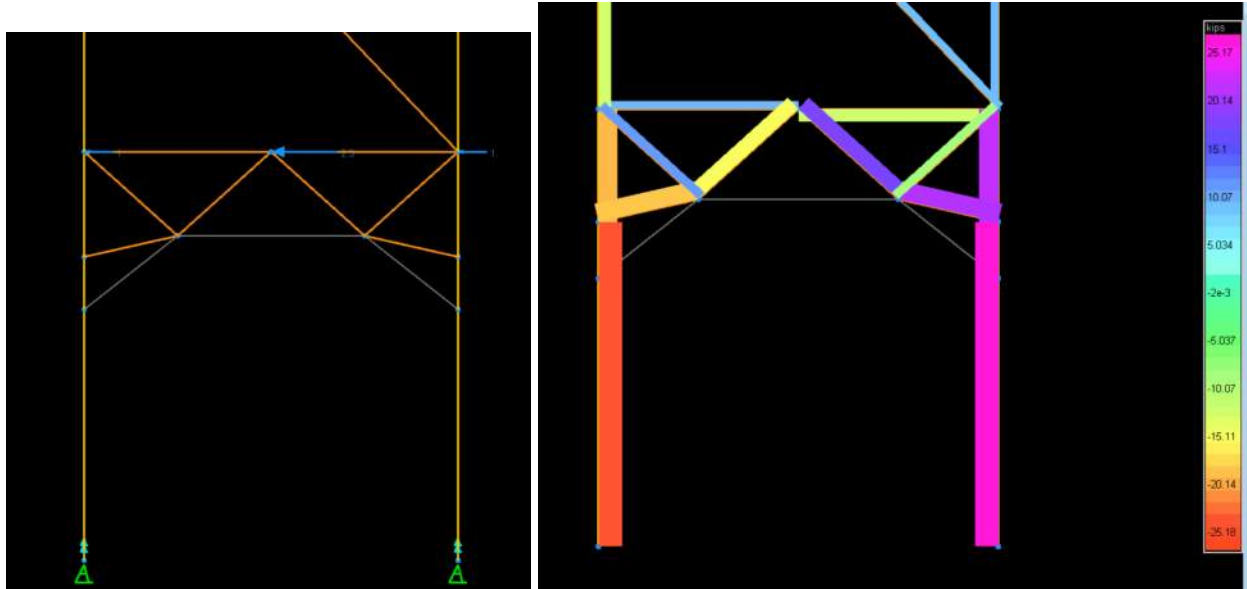
Modified 1967 configuration with damaged member removed (left) with member axial forces (right). Note the remaining member forces appear to be essentially unchanged, with only minor differences resulting from re-distribution of the approximate 100-lb force previously present in the bottom chord that was removed. Maximum member axial force increases were less than 1% when re-analyzed in this condition.

The damaged bottom chord of the portal truss appears to be a zero force member under this loading. The portal brace is subject to reverse curvature bending from transverse wind forces and an inflection point for moment is expected at the mid point of the system. The bottom chord is a zero force member as a result of there being zero moment at the transverse mid point of the portal system. Note that this analysis is also valid for the front truss.
