Memo

Project: Hood River – White Salmon Bridge

Subject: **WA and OR Approach Spans Bridge Deck Inspection**

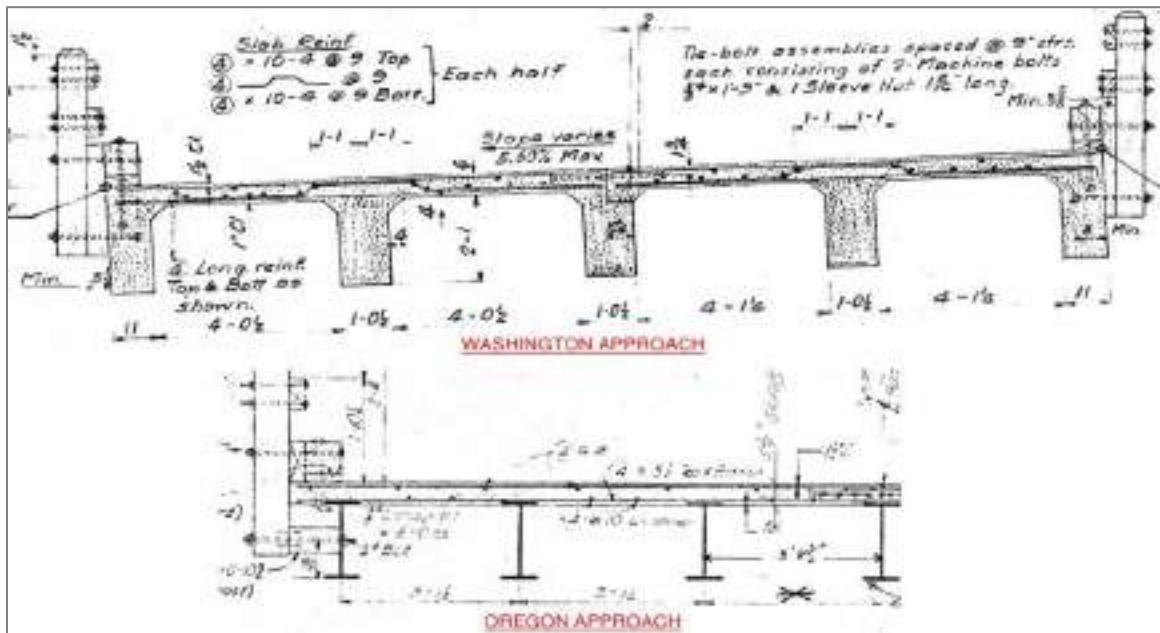
Figure 1. Reinforced Deck Section

According to the 1951 plans, the Washington approach deck is 6 inches thick with 1.5 inches of clear cover to the top transverse reinforcement, No. 4 bars at 9 inches, plus No. 4 “truss” bars at 9 inches (Figure 1). The top longitudinal reinforcement is No. 4 bars at about 2-foot centers. The Oregon approach deck is 5.25 inches thick with 1.5 inches of clear cover to the top transverse reinforcement, No. 4 bars at 5.5 inches. The top longitudinal reinforcement is No. 4 bars at 18 inches. The desired core size for chloride testing is 4 inches in diameter with a depth at least 2 inches below the range for testing; in this case, 4.5-inch deep cores. Deck cores were only taken on the Washington approach.

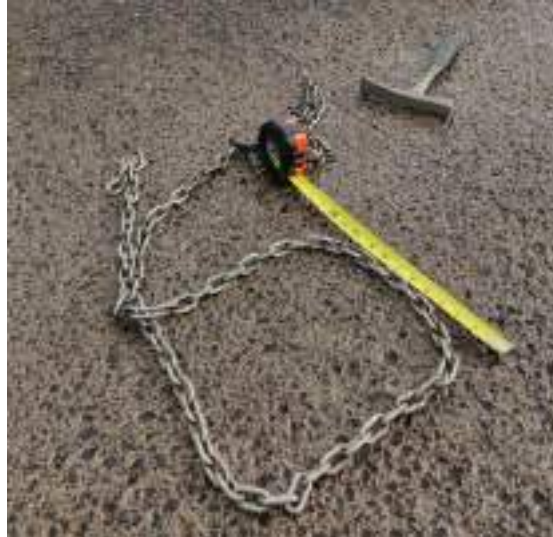
Figure 5. Chain Drag Equipment

One of the best ways of detecting delaminated concrete on a flat surface is to drag a chain back and forth across the surface. The hollow-sounding ring of delaminated concrete is readily detectable. When delaminated areas were located the area was outlined with spray paint and the area and location were measured for mapping (Figure 5). The chain drag inspection covered the entire deck of the Washington and Oregon concrete approach spans. The areas of

delamination are shown on *Attachment A - Core and Delamination Location Plan*. Multiple locations of exposed deck rebar were observed during the deck inspection, with broken and corroded bars present.

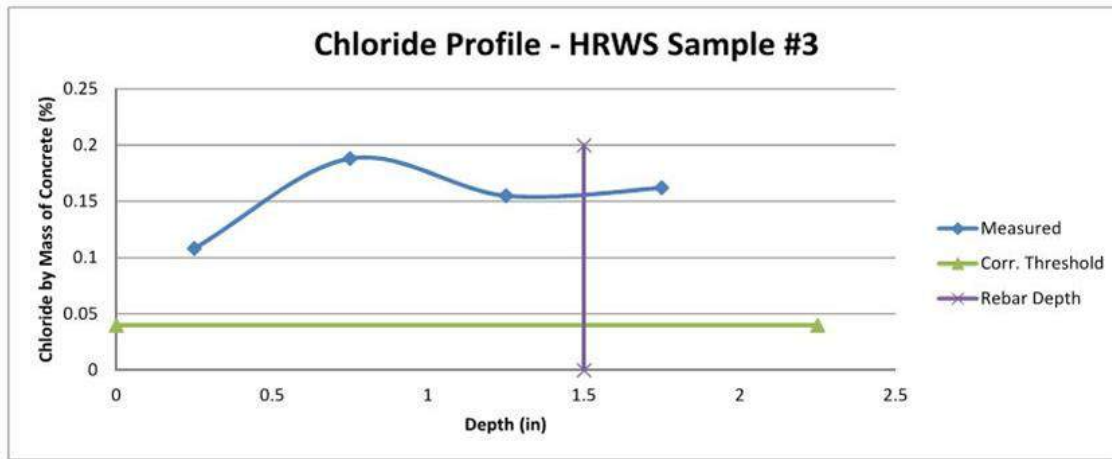
Figure 6. Core No. 3 Profile

Core No. 3 (Figure 6) is notably the worst sample with all four of the sections testing well above the corrosion threshold. Cores No. 2 and 4, are the next worse with all of the testable sections well above the corrosion threshold. While cores No. 2 and 4 did not have a test sample below the reinforcement depth, the chloride level would not be expected to suddenly drop below the corrosion threshold. All sections of core No. 5, which is the only core taken in the NB lane, are also above the corrosion threshold. All sections of core No. 1, which was taken the farthest away from the centerline in the SB lane and closest to the Washington abutment, are below the corrosion threshold.

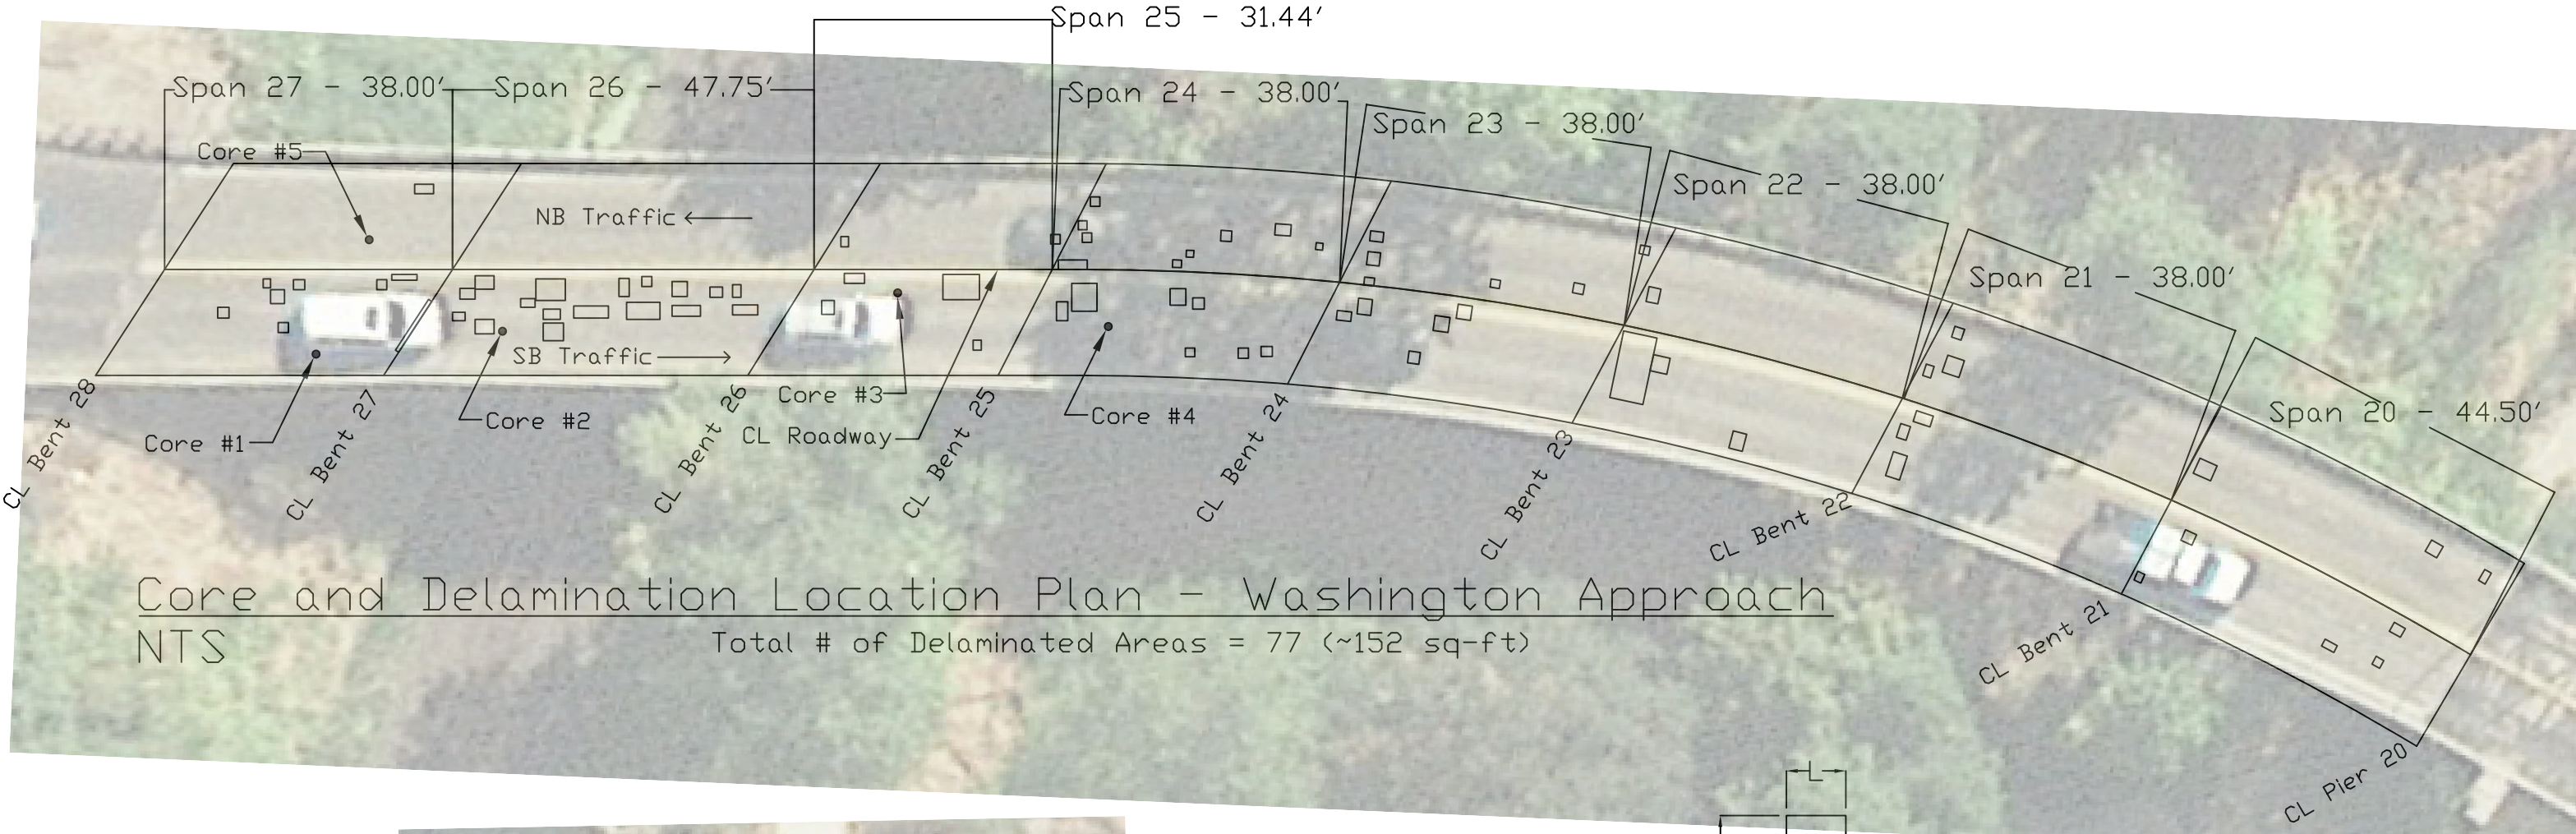
Core and Delamination Location Plan - Washington Approach

Total # of Delaminated Areas = 77 (~152 sq-ft)

Before proposing a recommended solution additional information is warranted. We recommend taking additional cores in both the Oregon and Washington concrete approach span decks to better define the limits of chloride contamination. We recommend two additional cores in the Oregon spans, one each in NB lane of Spans SD and SE, and four additional cores in the Washington spans; NB lane of Span 23, 24, and 26, and the SB lane of Span 23.

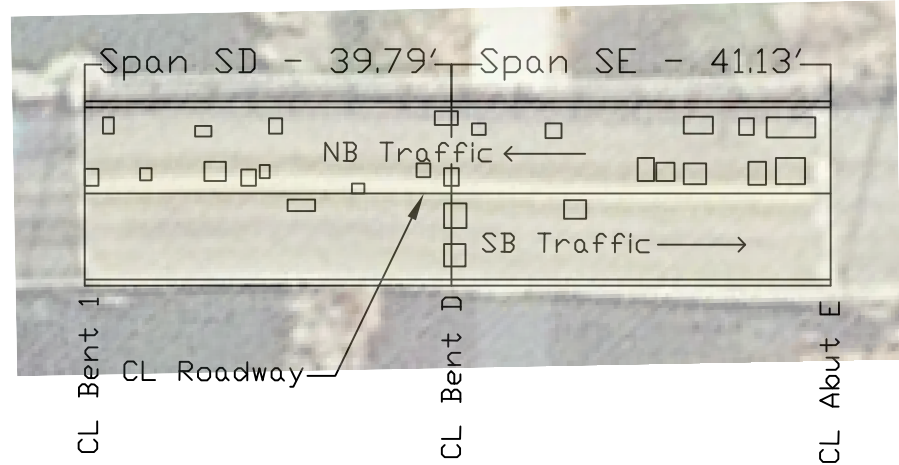
Core and Delamination Location Plan - Oregon Approach

For the Oregon approach, Spans SD and SE have a high concentration of delaminations in the NB lane and only a few delaminations in the SB lane. The high level of delaminations in the NB lane may be indicative of vehicles tracking salts used around the toll booth onto the bridge.

Total # of Delaminated Areas = 26 (~104 sq-ft)

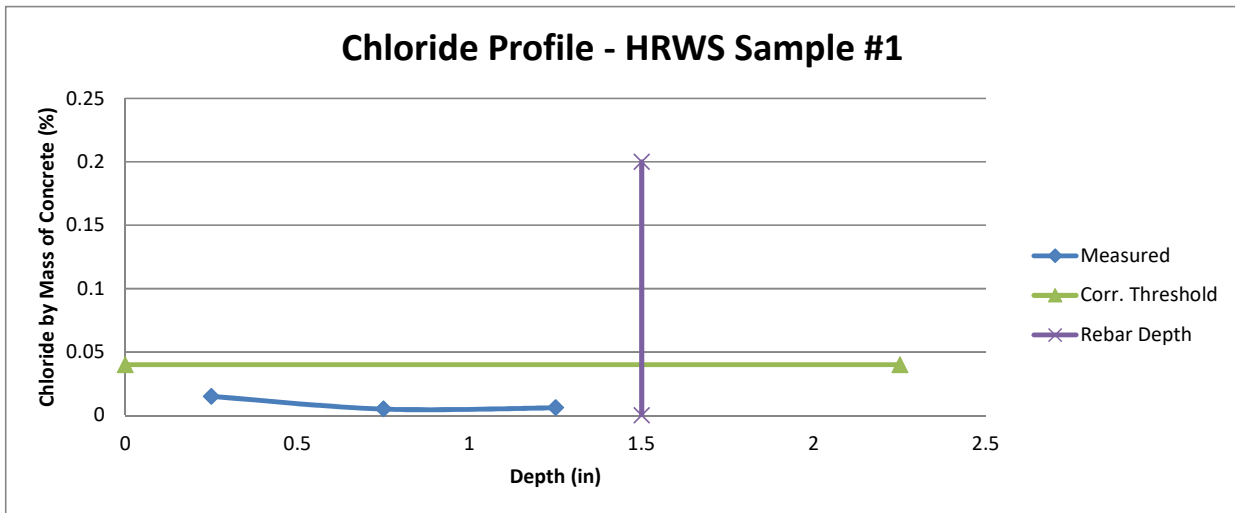
The results of core No. 1 is unexpected as this location would presumably have the highest chloride concentrations, being closest to source of salt (SR-14). Core No. 5 results also indicate that the high chloride content is not restricted to the SB lane. However, these tests are individual spot locations, and if five more cores were tested, five different concentrations could result. What is more indicative of an active corrosion condition is the high level of chloride in cores No. 2 through 5 (2-to-4 times the corrosion threshold) and the high frequency of delaminations

Hood River - White Salmon Bridge		Field Test Data		
Sample #: 1	Depth, in	0.25	0.75	1.25
Date: 5/15/2019	Chloride Concentration	0.015	0.005	0.006

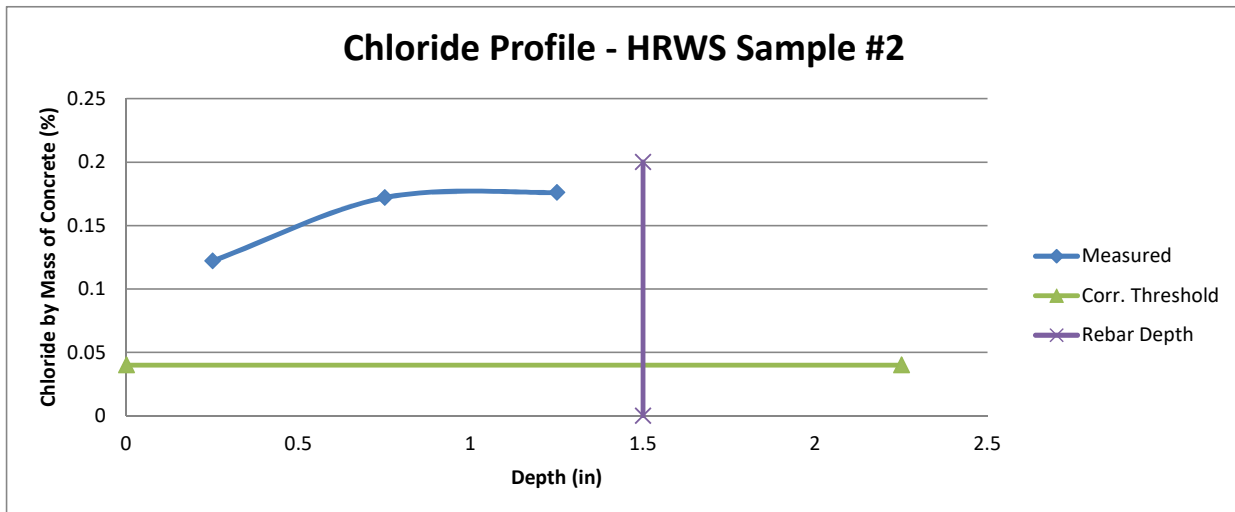
Hood River - White Salmon Bridge		Field Test Data		
Sample #: 2	Depth, in	0.25	0.75	1.25
Date: 5/15/2019	Chloride Concentration	0.122	0.172	0.176

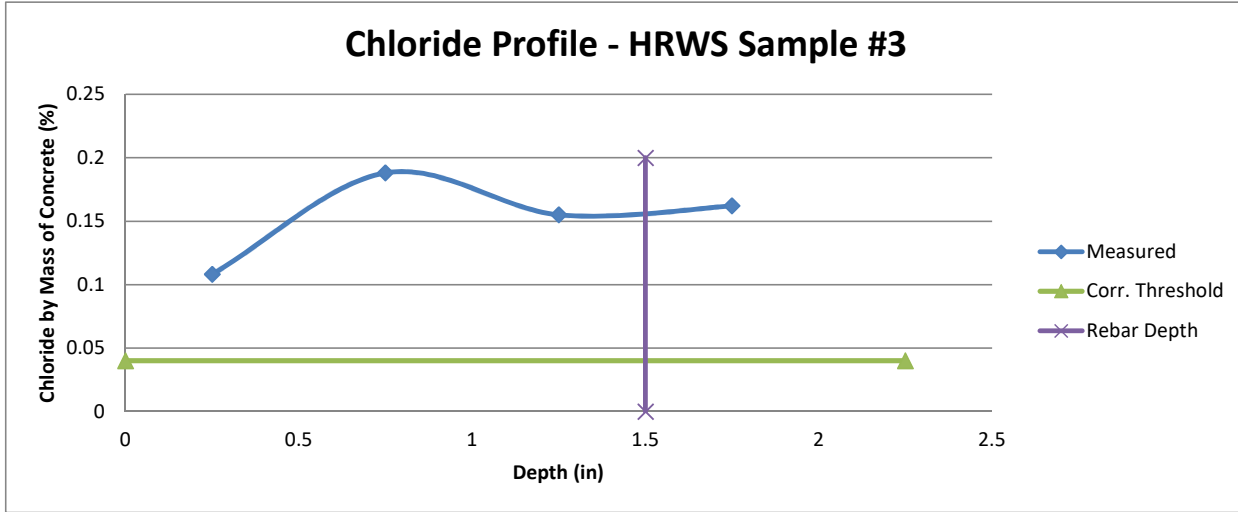
Hood River - White Salmon Bridge		Field Test Data			
Sample #: 3	Depth, in	0.25	0.75	1.25	1.75
Date: 5/15/2019	Chloride Concentration	0.108	0.188	0.155	0.162

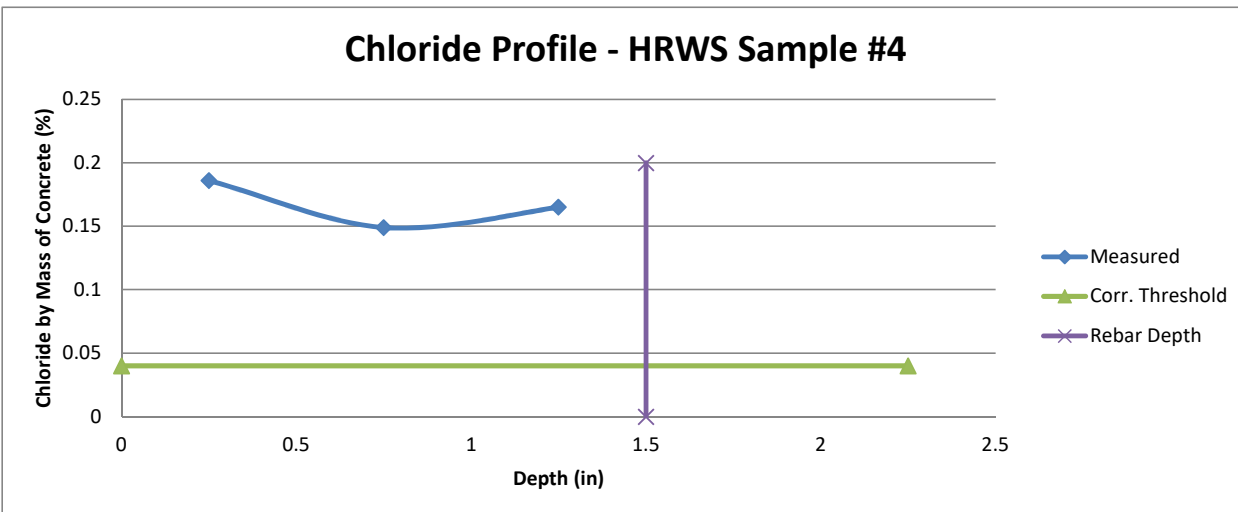
Hood River - White Salmon Bridge		Field Test Data		
Sample #: 4	Depth, in	0.25	0.75	1.25
Date: 5/15/2019	Chloride Concentration	0.186	0.149	0.165

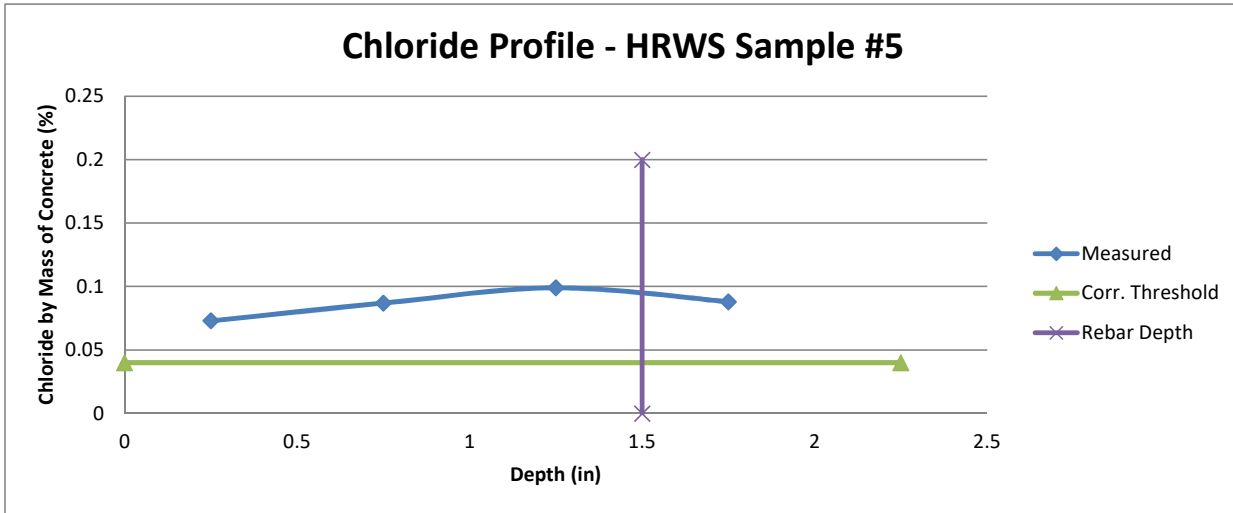
Hood River - White Salmon Bridge		Field Test Data			
Sample #: 5	Depth, in	0.25	0.75	1.25	1.75
Date: 5/15/2019	Chloride Concentration	0.073	0.087	0.099	0.088

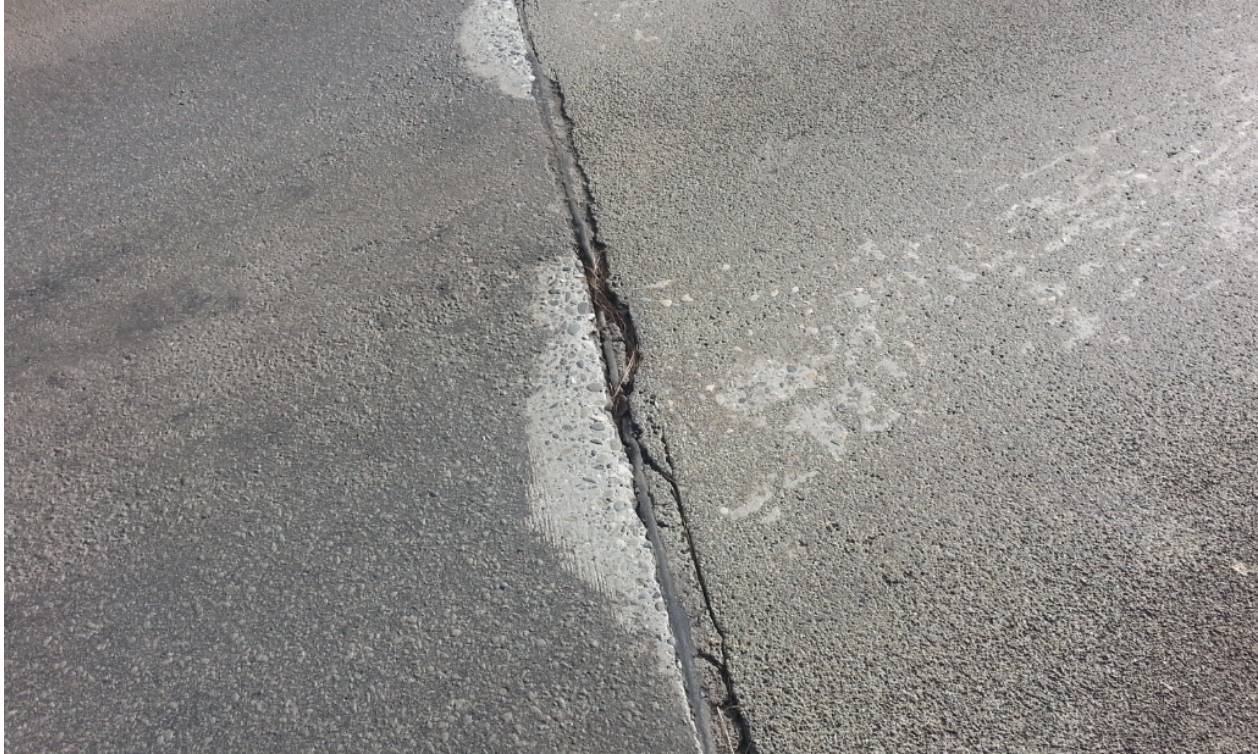
Joint at Washington Abutment (Bent 28).

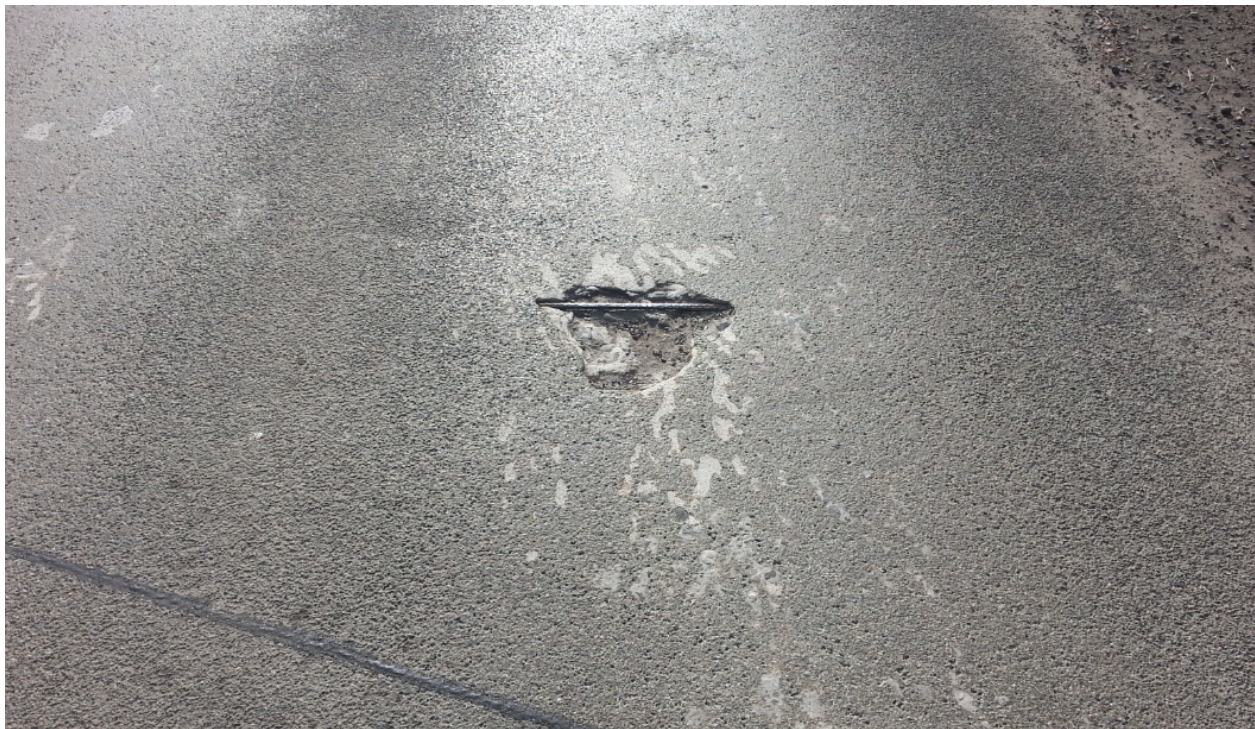
Pothole in Span 26, Joint at Bent 27.

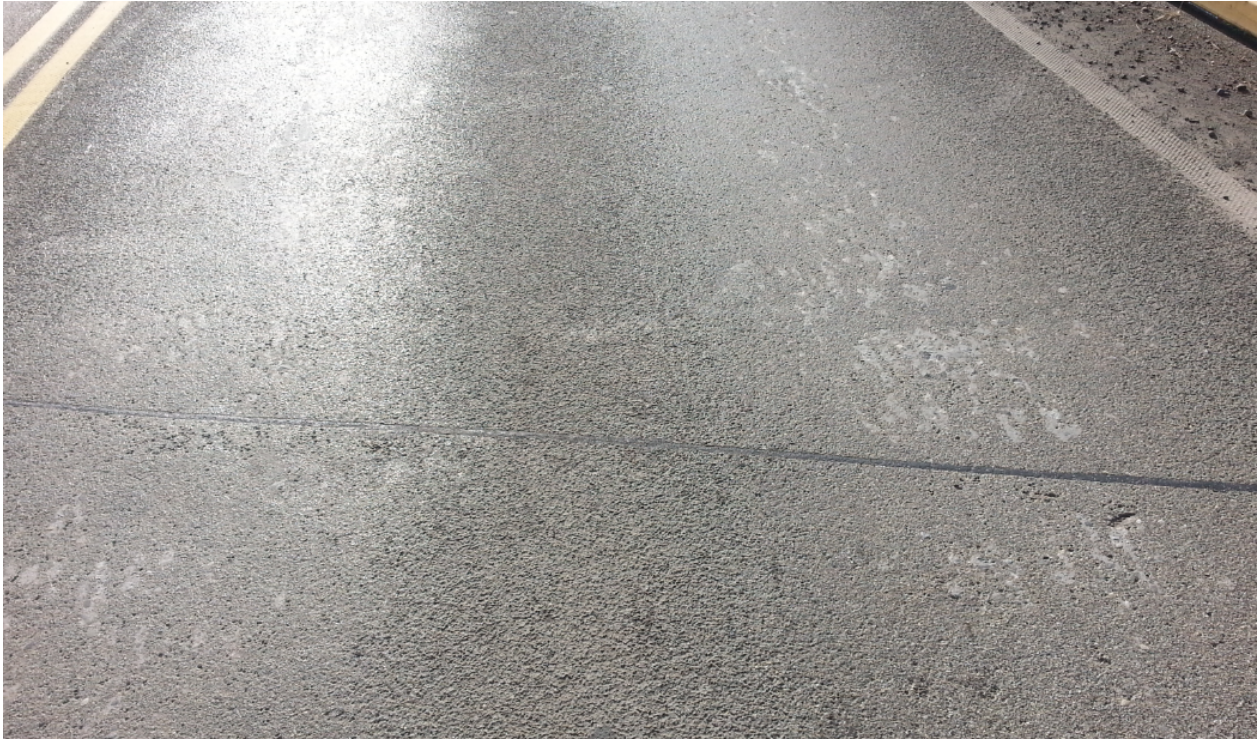
The polymer overlay on both approach sections is worn through in much of the wheel paths and no longer providing much protection to the deck. Installing a new overlay on top of the deck in its current condition is not recommended due to the findings of high chloride content. The concern is that the level of chlorides trapped beneath the overlay will continue the corrosion of reinforcement, causing continued delamination and spalling of concrete and the overlay.

Worn overlay near Bent 25.

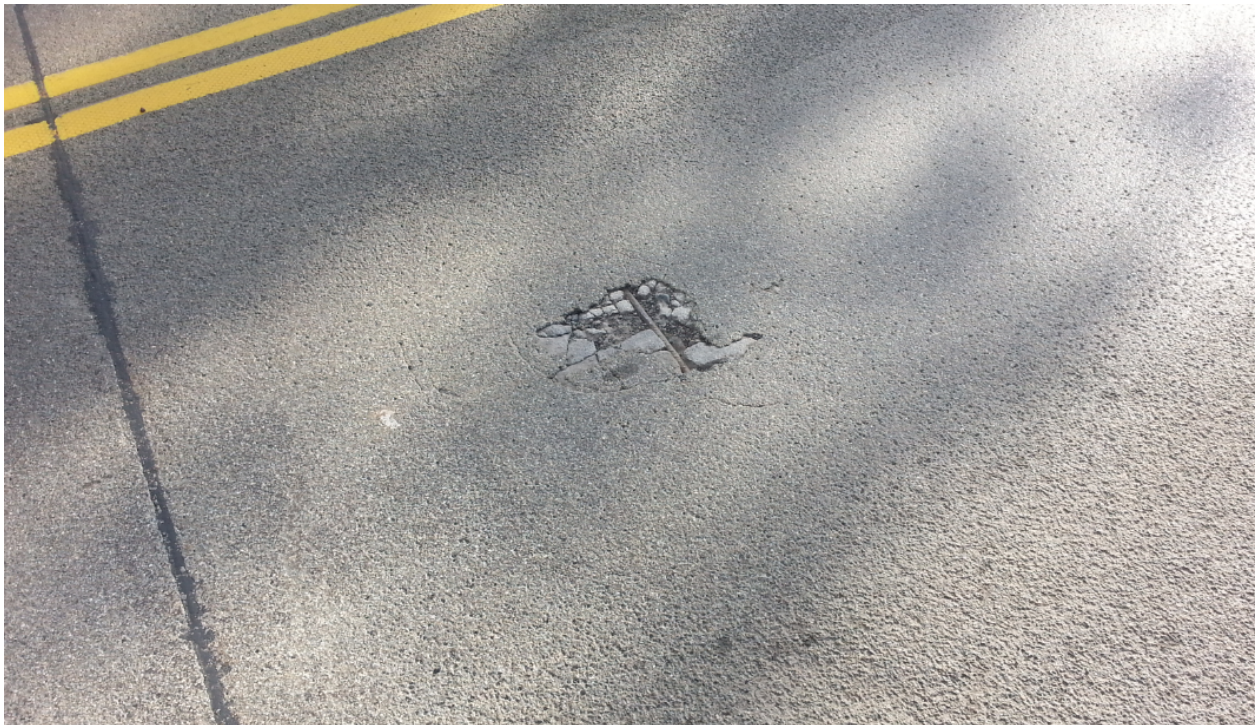
Pothole in Span 22, Joint at Bent 23.

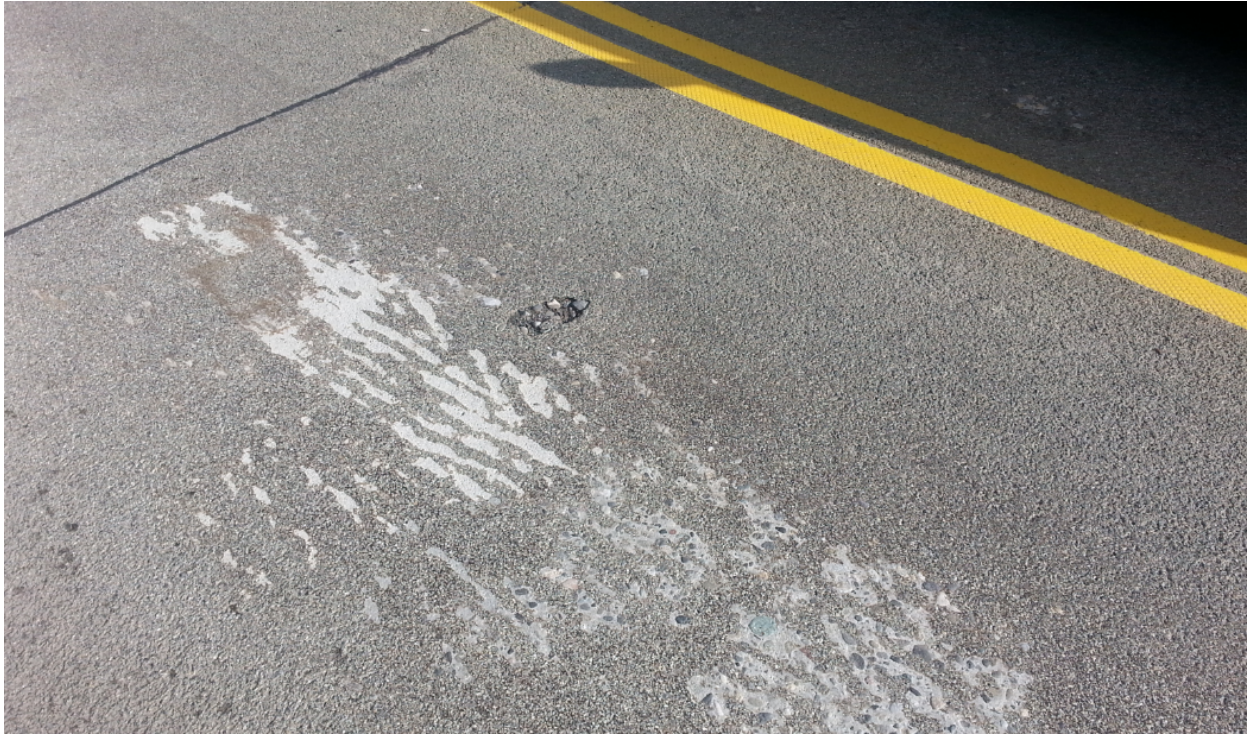
Worn overlay near Bent 22.

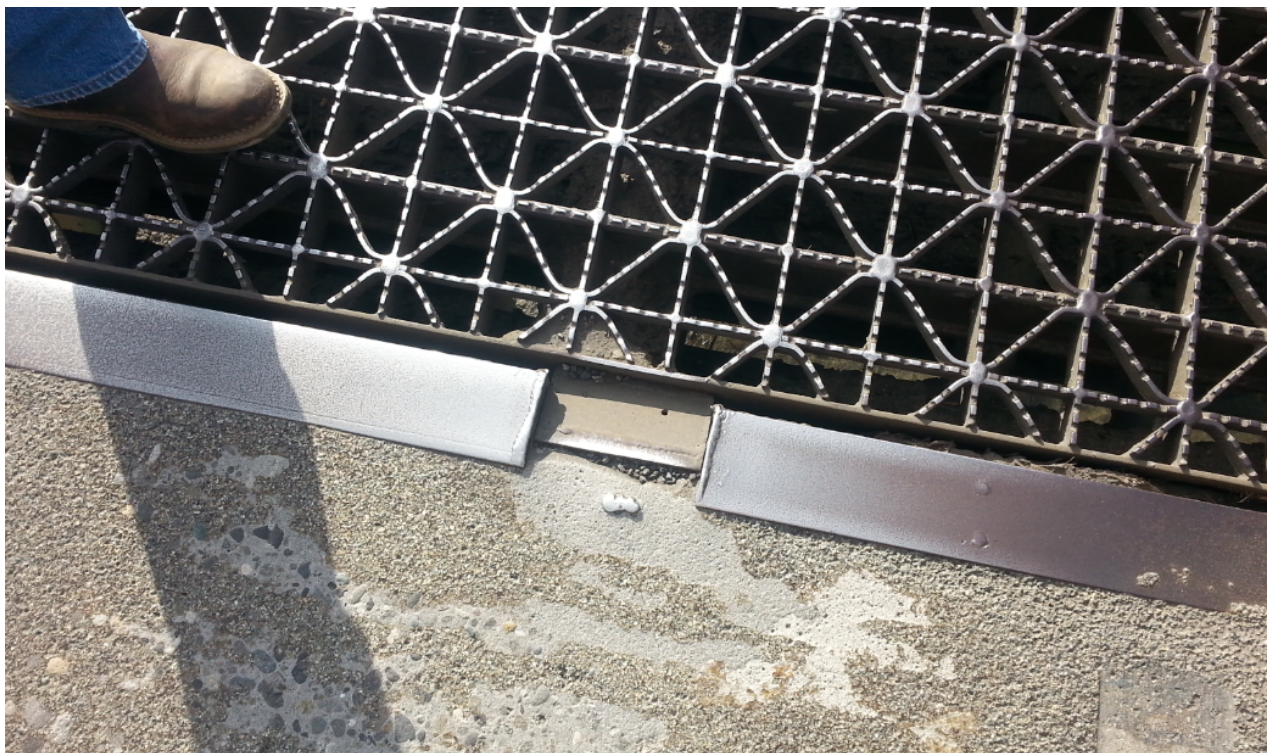
Broken steel header at Bent 20.
