PORT OF HOOD RIVER COMMISSION

AGENDA

Project: Hood River - White Salmon Interstate Bridge (ODOT Bridge Number 06645)

Subject: **2024 Portal Damage Assessment**

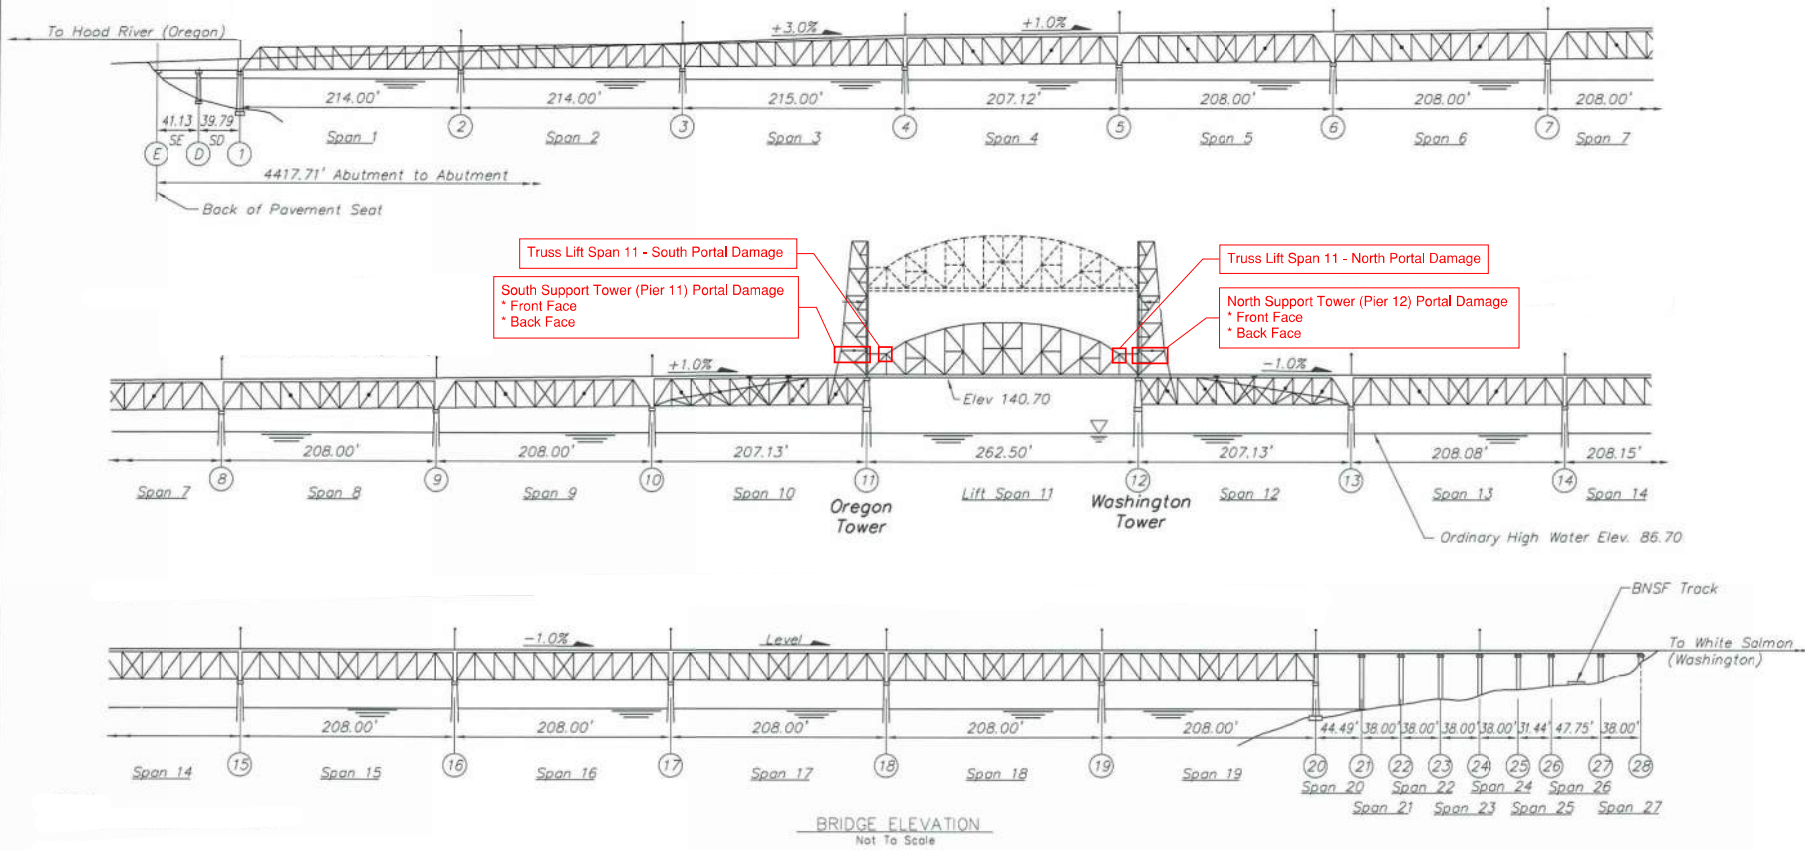
Observed Damage Locations

- Damage is consistent at the three (3) north and (3) south locations.
- Damage is isolated to the portal frame members and interior connections (gusset plate, bolts, and rivets) and damage did not propagate to the primary members of the tower supports (front and back legs) and lift span truss chords.
- The vertical load assessment was specific to dead load and the vehicular live load.
- The horizontal load assessment was specific to wind on structure loads.
- The lift span truss is adequately seated in a lowered position thereby limiting the assessment of the tower support (back and front legs) to dead and wind on structure loads.
- The lift span truss will remain in a lowered position until corrective work is performed.

- The existing bridge lift span should remain in place and not be raised until all damaged portal bracing is repaired.
- At the discretion of the Port, resumption of marine traffic under the bridge may proceed provided the Port can determine that there is sufficient vertical clearance to do so without raising the lift span.
- At the discretion of the Port, reopening of the bridge to vehicular traffic may proceed provided that vehicles are compliant with the posted load rating of the bridge.
- Design of final bridge repair plans, specifications, and estimate should be expedited with the resulting repairs to follow immediately thereafter.

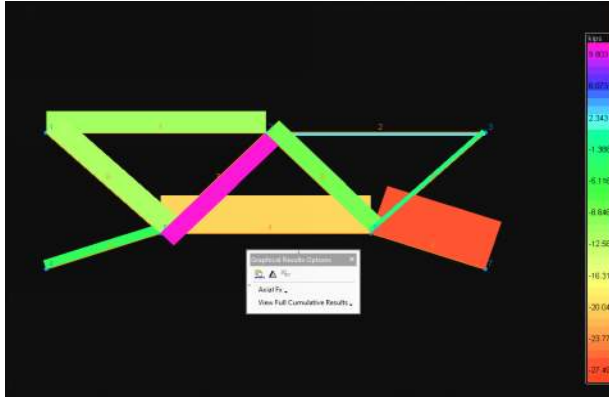
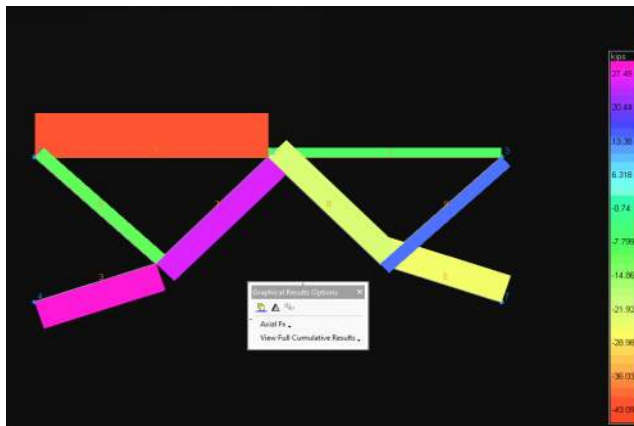
Analysis Results: Assuming middle bottom chord goes out of service

Note: Top chord is the critical member for checking.
Anticipated Maximum Force -56.43 kips <<Bracing+WS-STRIII, Post damage

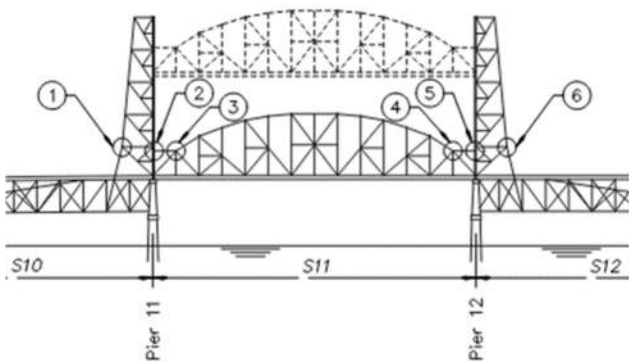
- ① South Support Tower (Pier 11), Back Face
- ② South Support Tower (Pier 11), Front Face
- ③ South End Portal of Truss Lift Span 11

- ④ North End Portal of Truss Lift Span 11
- ⑤ North Support Tower (Pier 12), Front Face
- ⑥ North Support Tower (Pier 12), Back Face

The front and back portal frames of the North and South lift span support towers of the Hood River-White Salmon Bridge were damaged by a vehicle on 6/27/2024. An analysis of the primary tower members of the back and front towers of the lift span was performed assuming the portal frames were no longer bracing the towers. The slenderness ratio and associated compressive capacity of these primary tower members were compared to the unaffected members above to determine if the reduced capacity controlled the vertical capacity of the towers. The figures below show the face and back of the tower with the substantially damaged portal frame highlighted in red, primary tower members with increased unbraced length in blue, and the primary tower members in the bay above in green.

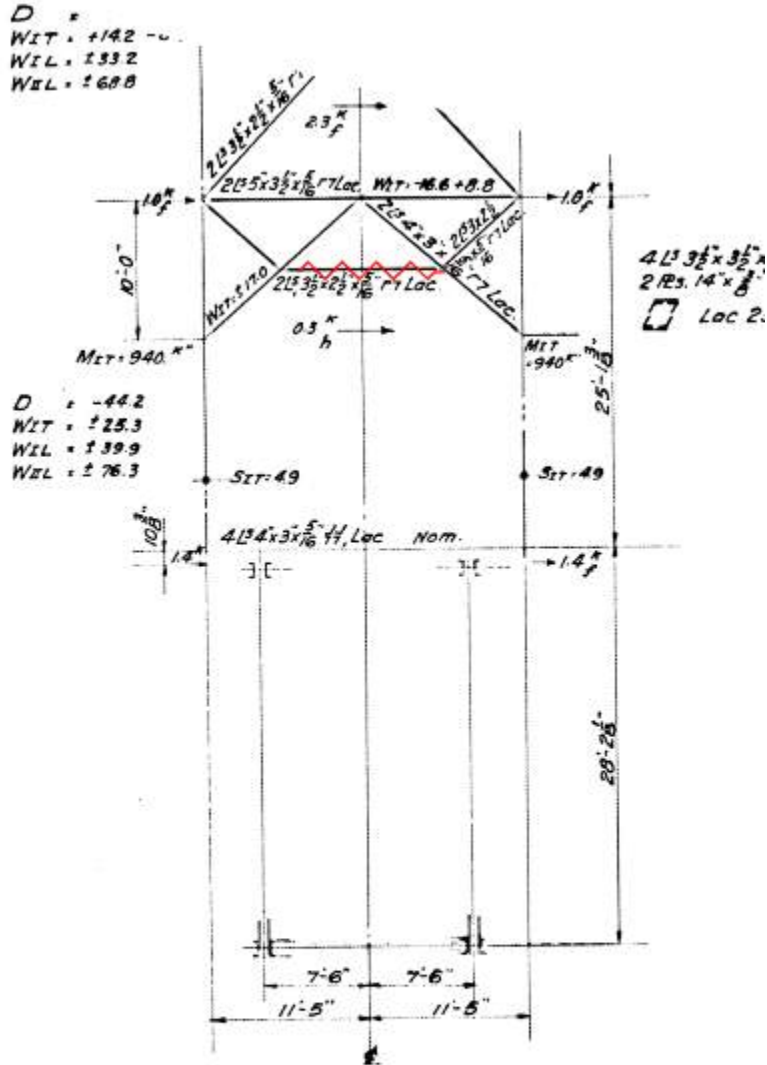
BACK OF TOWER

The substantially damaged member for this analysis is shown below. The analysis appears to show that this bottom chord member of the portal truss can be completely removed with no adverse impact on the structure's ability to resist wind loads.

The damaged bottom chord of the portal truss appears to be a zero force member under this loading. The portal brace is subject to reverse curvature bending from transverse wind forces and an inflection point for moment is expected at the mid point of the system. The bottom chord is a zero force member as a result of there being zero moment at the transverse mid point of the portal system. Note that this analysis is also valid for the front truss.

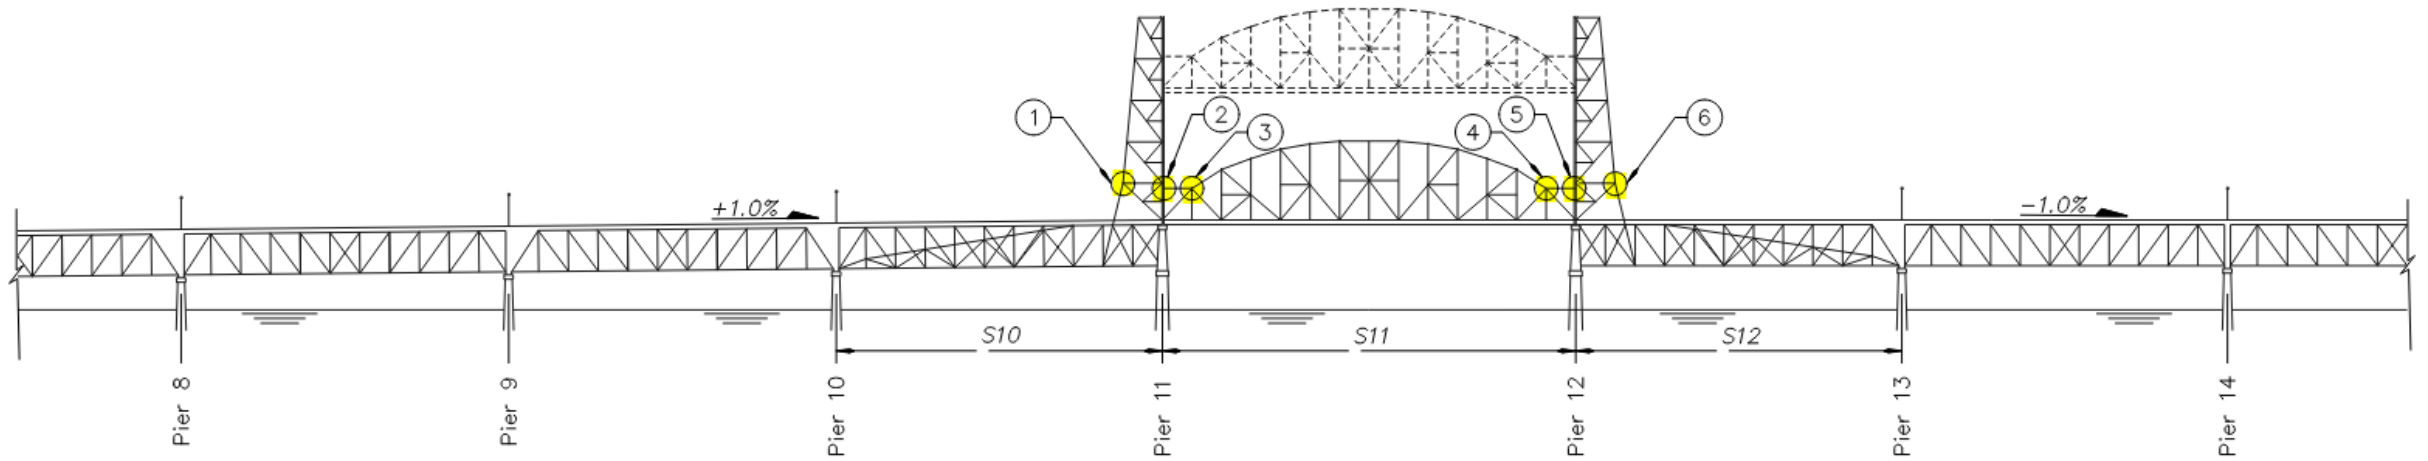
Bridge Assessment Field Observations

- Six (6) damage locations to overhead portal braces were identified
 - South Support Tower (Pier 11), Back Face
 - South Support Tower (Pier 11), Front Face
 - South End Portal of Truss Lift Span 11
 - North Support Tower (Pier 12), Back Face
 - North Support Tower (Pier 12), Front Face
 - North End Portal of Truss Lift Span 11

- Temporary Condition: The existing bridge lift span should remain in place and not be raised until all damaged portal bracing is repaired.
- At the discretion of the Port, marine traffic under the bridge may continue provided the Port can determine that there is sufficient vertical clearance to do so without raising the lift span.
- At the discretion of the Port, reopening of the bridge to vehicular traffic may proceed provided that vehicles are compliant with the posted load rating of the bridge.
 - Implementation: Limit traffic to cars to mitigate the potential for another accidental strike to the overhead bracing while the bridge is in a damaged state.
- Design of final bridge repair plans, specifications, and estimate should be expedited with the resulting repairs to follow immediately thereafter.
